Georgetown

GENERAL INFORMATION

Address	6600 E State Blvd Fort Wayne, IN 46815
Building Size	19,500 SF
Site Area	1.62 Acres
On Site Parking	48
Year Built	2004
Original Architect	Moake Park Group

BRANCH CONDITION

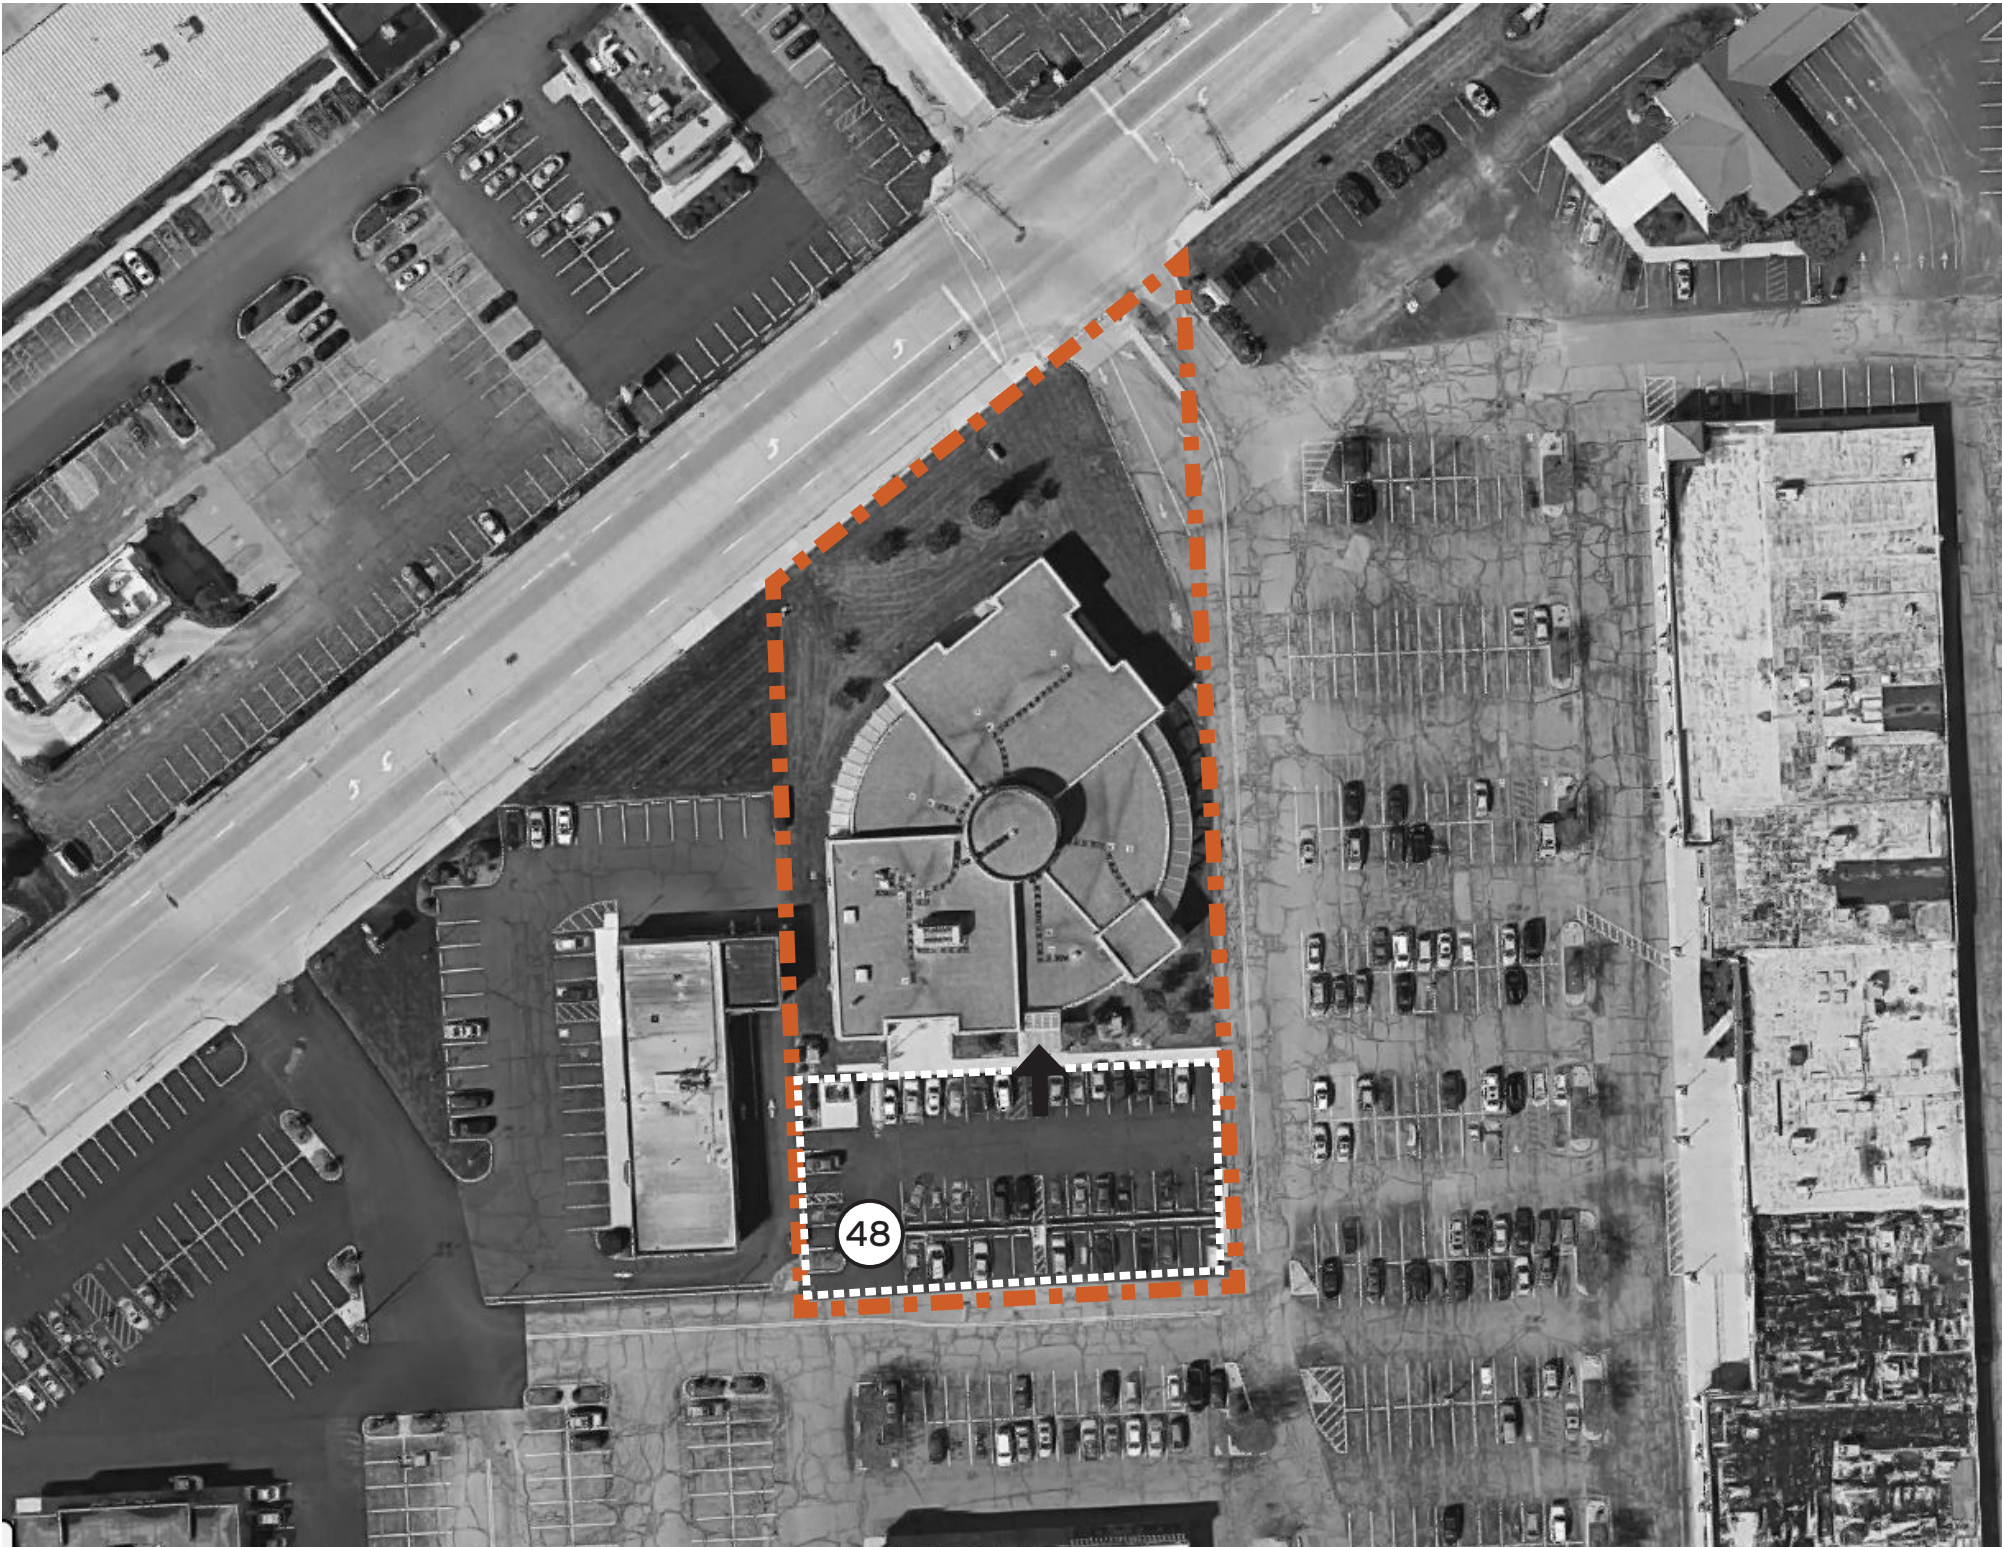
Site Plan

The branch has good visibility from East State Road, a primary thoroughfare in the community, and the building design projects some presence as a library. The standard blue ACPL signage is easily visible and well-located at the entrance to the mixed-use retail that surrounds the library on three sides. The library location is considered convenient by the patrons who use it.

The parking lot is small and challenging to navigate, and the largest concern to survey respondents. The configuration and access from a busy retail development can be hazardous given competition with non-library traffic, including the difficulty of access from the lower level of parking on the south side of the site. The lot includes only one dedicated ADA spot, inadequate for this site.

After school the exterior and entrance area become overcrowded with school age patrons, creating noise, congestion, and hazards with arriving and departing vehicles. There are no sidewalks for students to walk safely.

The surrounding traffic patterns and slope of green spaces leave no viable outdoor public programming, although a few areas of seating could be added within green spaces along the east side of the building.

The property has no viable space for any significant building expansion. A possibility exists to enclose spaces under the sunshades along curved sections of the building, which could add minimal square footage but at a relatively high cost.

The location of the materials drop is hard to find
