Little Turtle

GENERAL INFORMATION

Address	2201 Sherman Blvd Fort Wayne, IN 46808
Building Size	13,150 SF
Site Area	1.04 Acres
On Site Parking	55
Year Built	1972, Renovation 2006
Original Architect	Vintage Archonics

BRANCH CONDITION

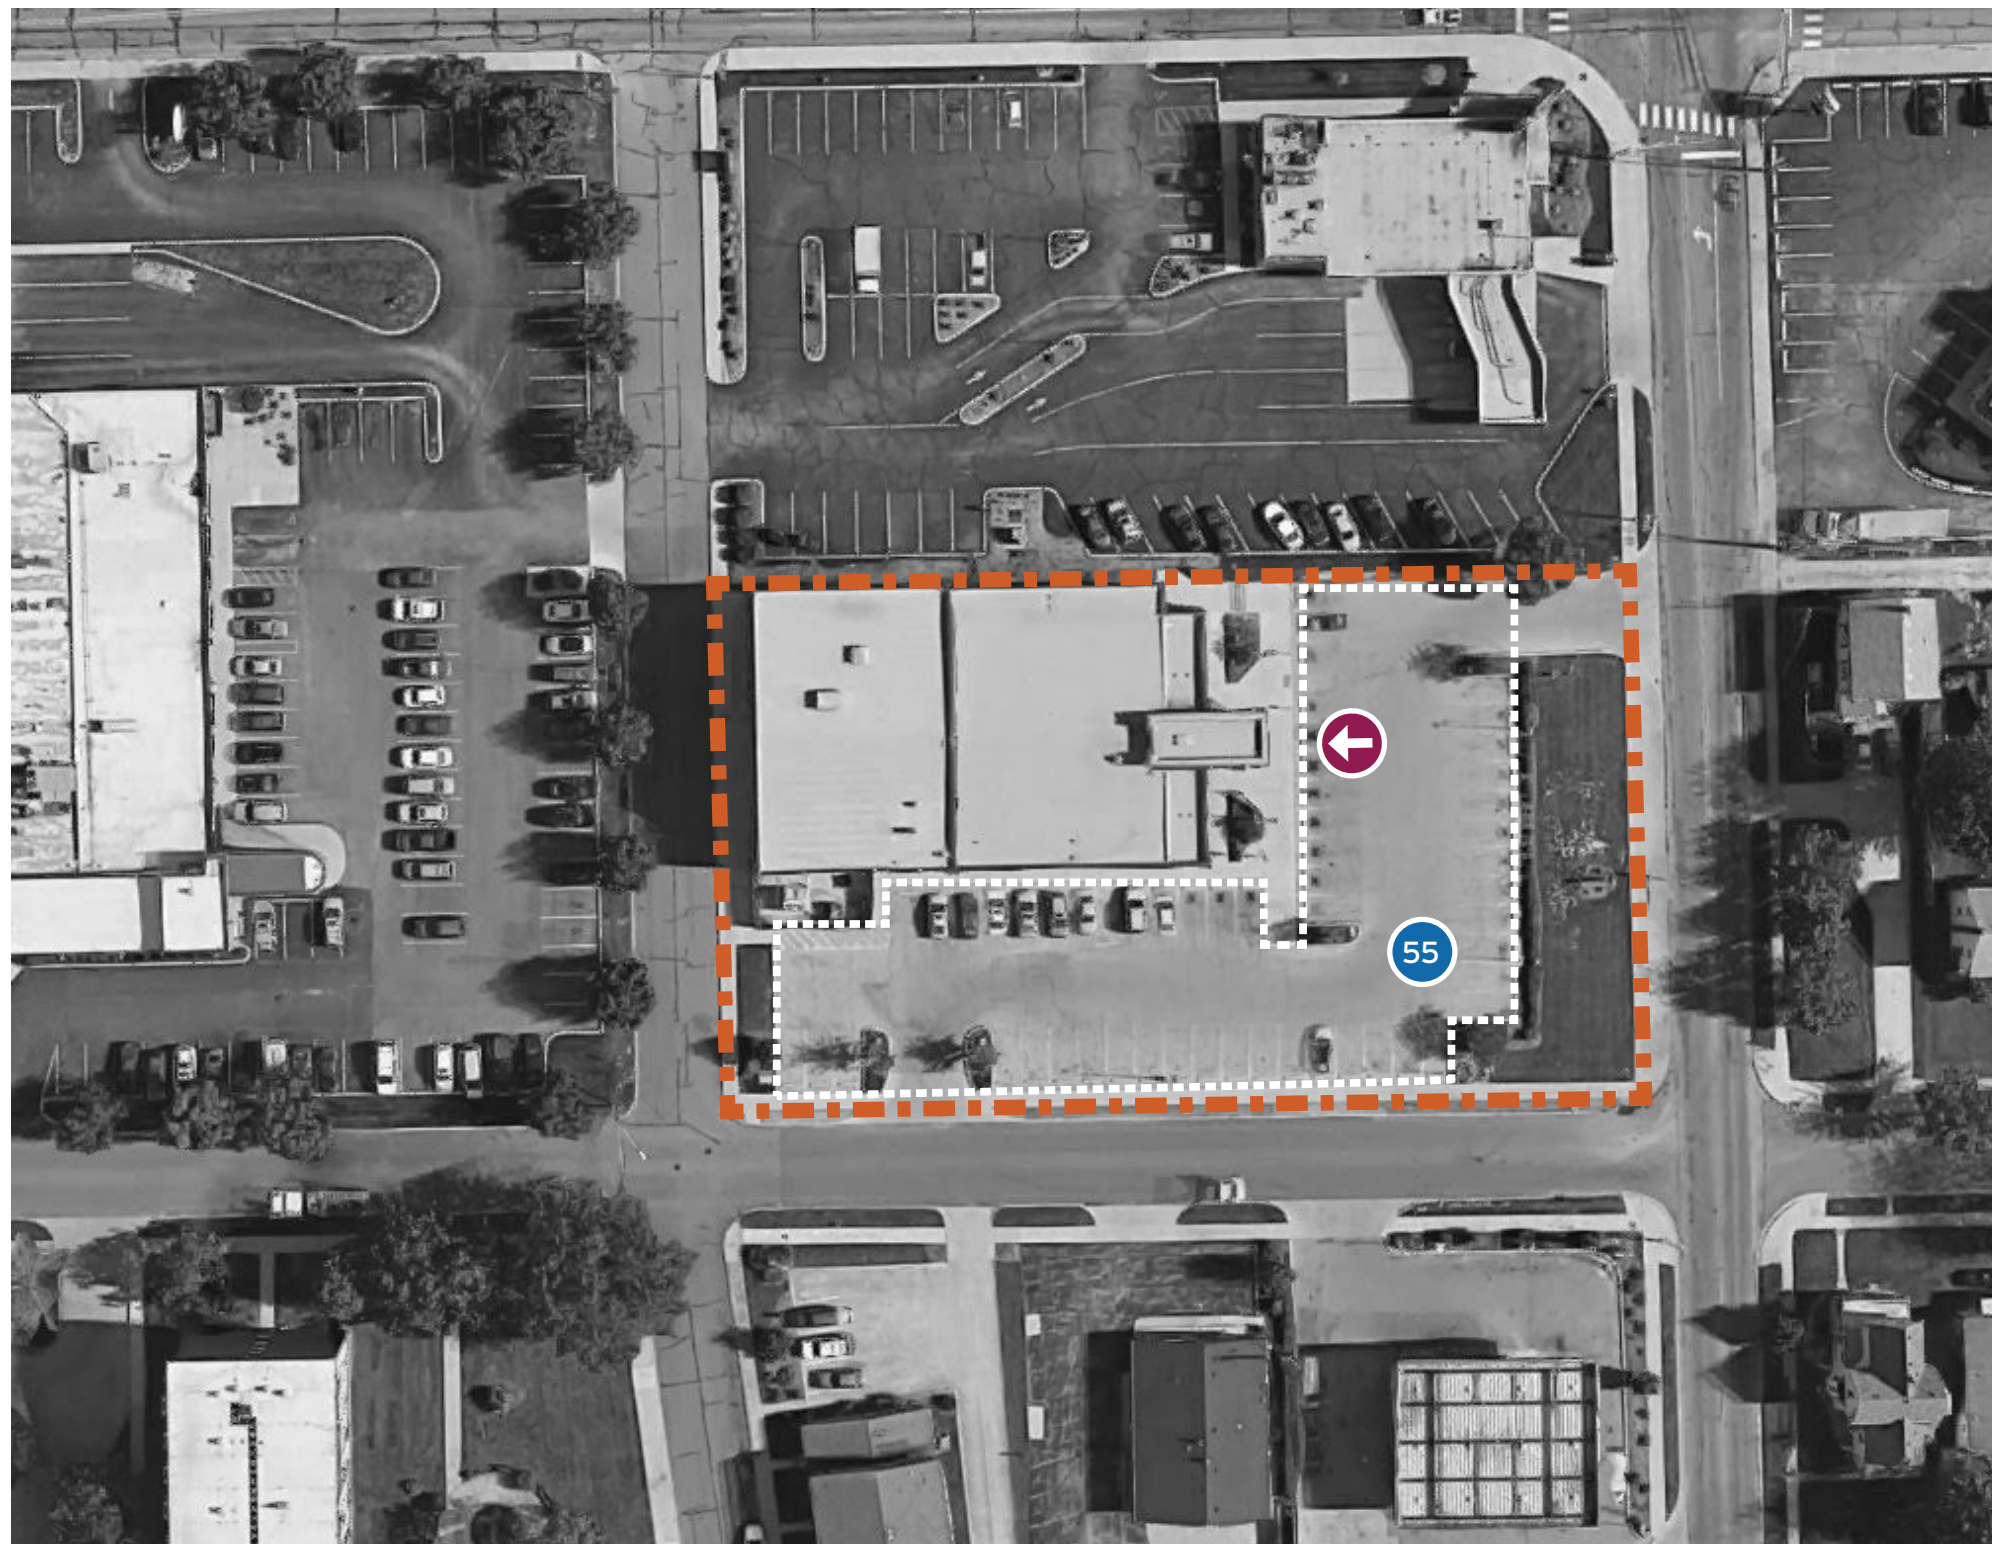
Site Plan

The branch and library sign are easily visible from Sherman Boulevard, however there is no presence from the main thoroughfare half a block to the north, West State Boulevard. The building design does not project significant presence as a library.

The parking lot includes 54 spaces, easily accessed and obvious from the street. The site has no green space, only the parking areas that could be used for outdoor programming.

The property could accommodate modest expansion into the parking areas to east and south.
