Shawnee

GENERAL INFORMATION

Address	5600 Noll Ave Fort Wayne, IN 46806
Building Size	11,200 SF
Site Area	1.43 Acres
On Site Parking	22
Year Built	1973, Renovation 2003
Original Architect	Jankowski Schultz

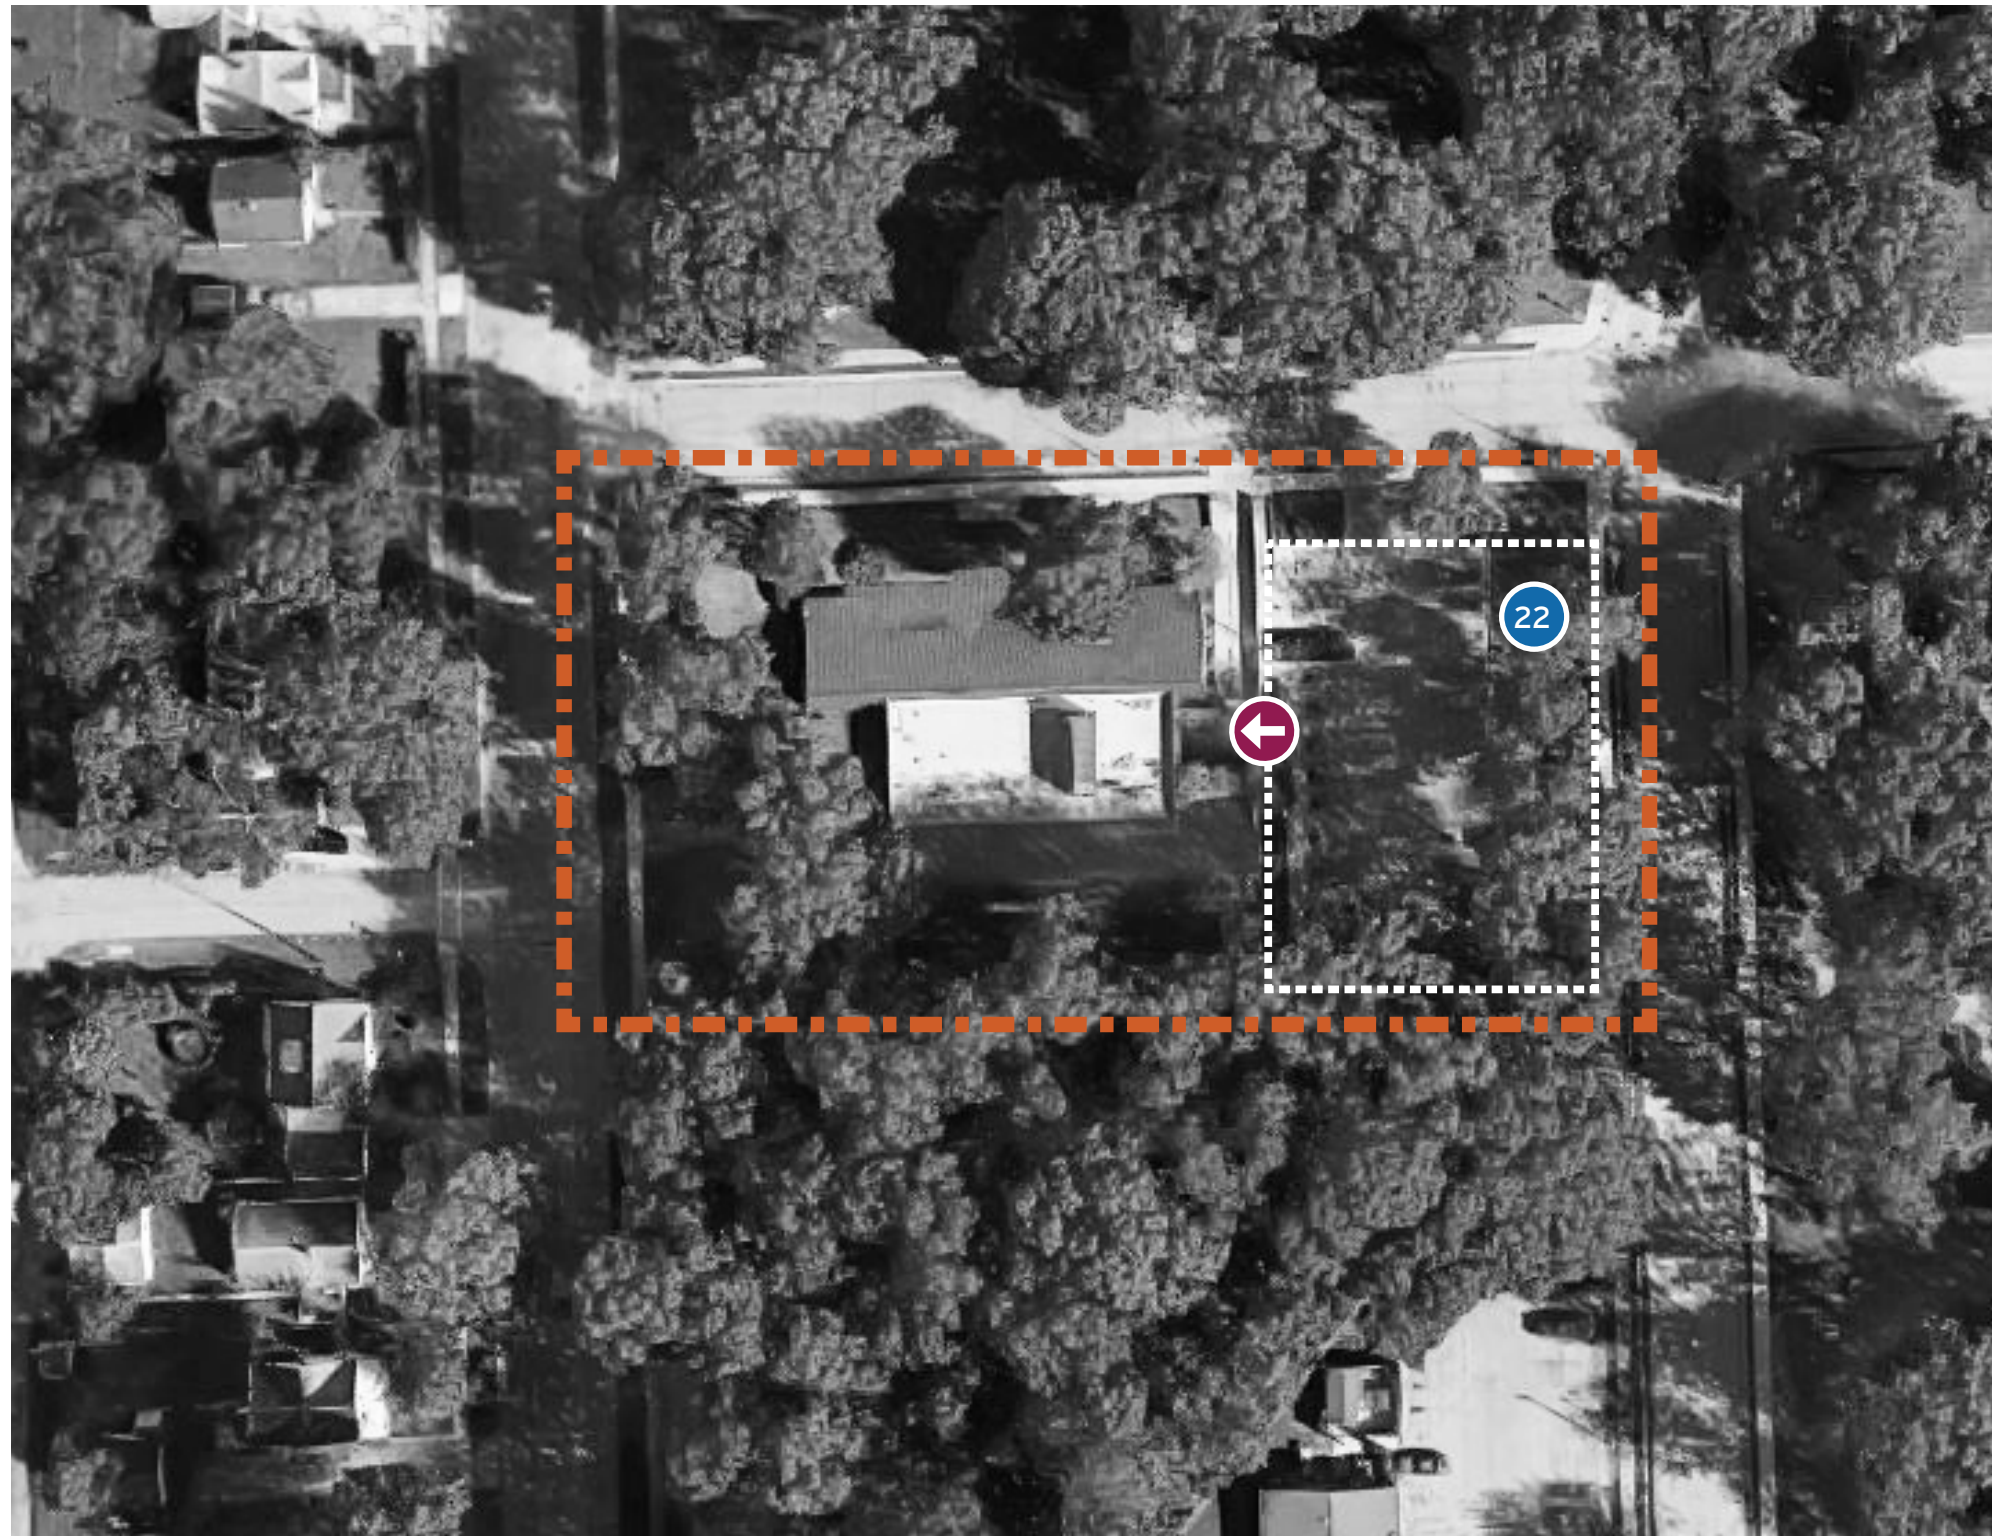
Site Plan

The branch is somewhat visible from the address street Noll Avenue, but more visible from Doan Drive to the south and South Calhoun Street to the west. Calhoun is the largest of the three streets, but none are major thoroughfares for this part of Fort Wayne, as are Paulding Road a block south or Lafayette Street a few blocks to the east.

Even at the streets that border the site, the building projects negligible presence as a library, given the design placed much of the building below grade on a sloping site and the roof is the defining exterior feature.

The parking lot includes 22 spaces, accessed from Doan Drive only, which is undersized for busy times and/or when special programs/ events are being held.

The parking limitations, level changes, and below-grade main entrance are all inadequate and are a barrier to access for this library. Accessible parking is provided but the ramp to access the main entrance is unacceptably long and can be dangerous in bad weather.

The site includes some green space along the north and west sides, and between the parking lot and Noll Avenue. Some areas could be developed for outdoor programming, but all this green space is sloped and wooded.

The site could theoretically accommodate a branch expansion to the west, but it would be very expensive due to the slope of the site and the nature of existing architecture.
