Waynedale

GENERAL INFORMATION

BRANCH CONDITION

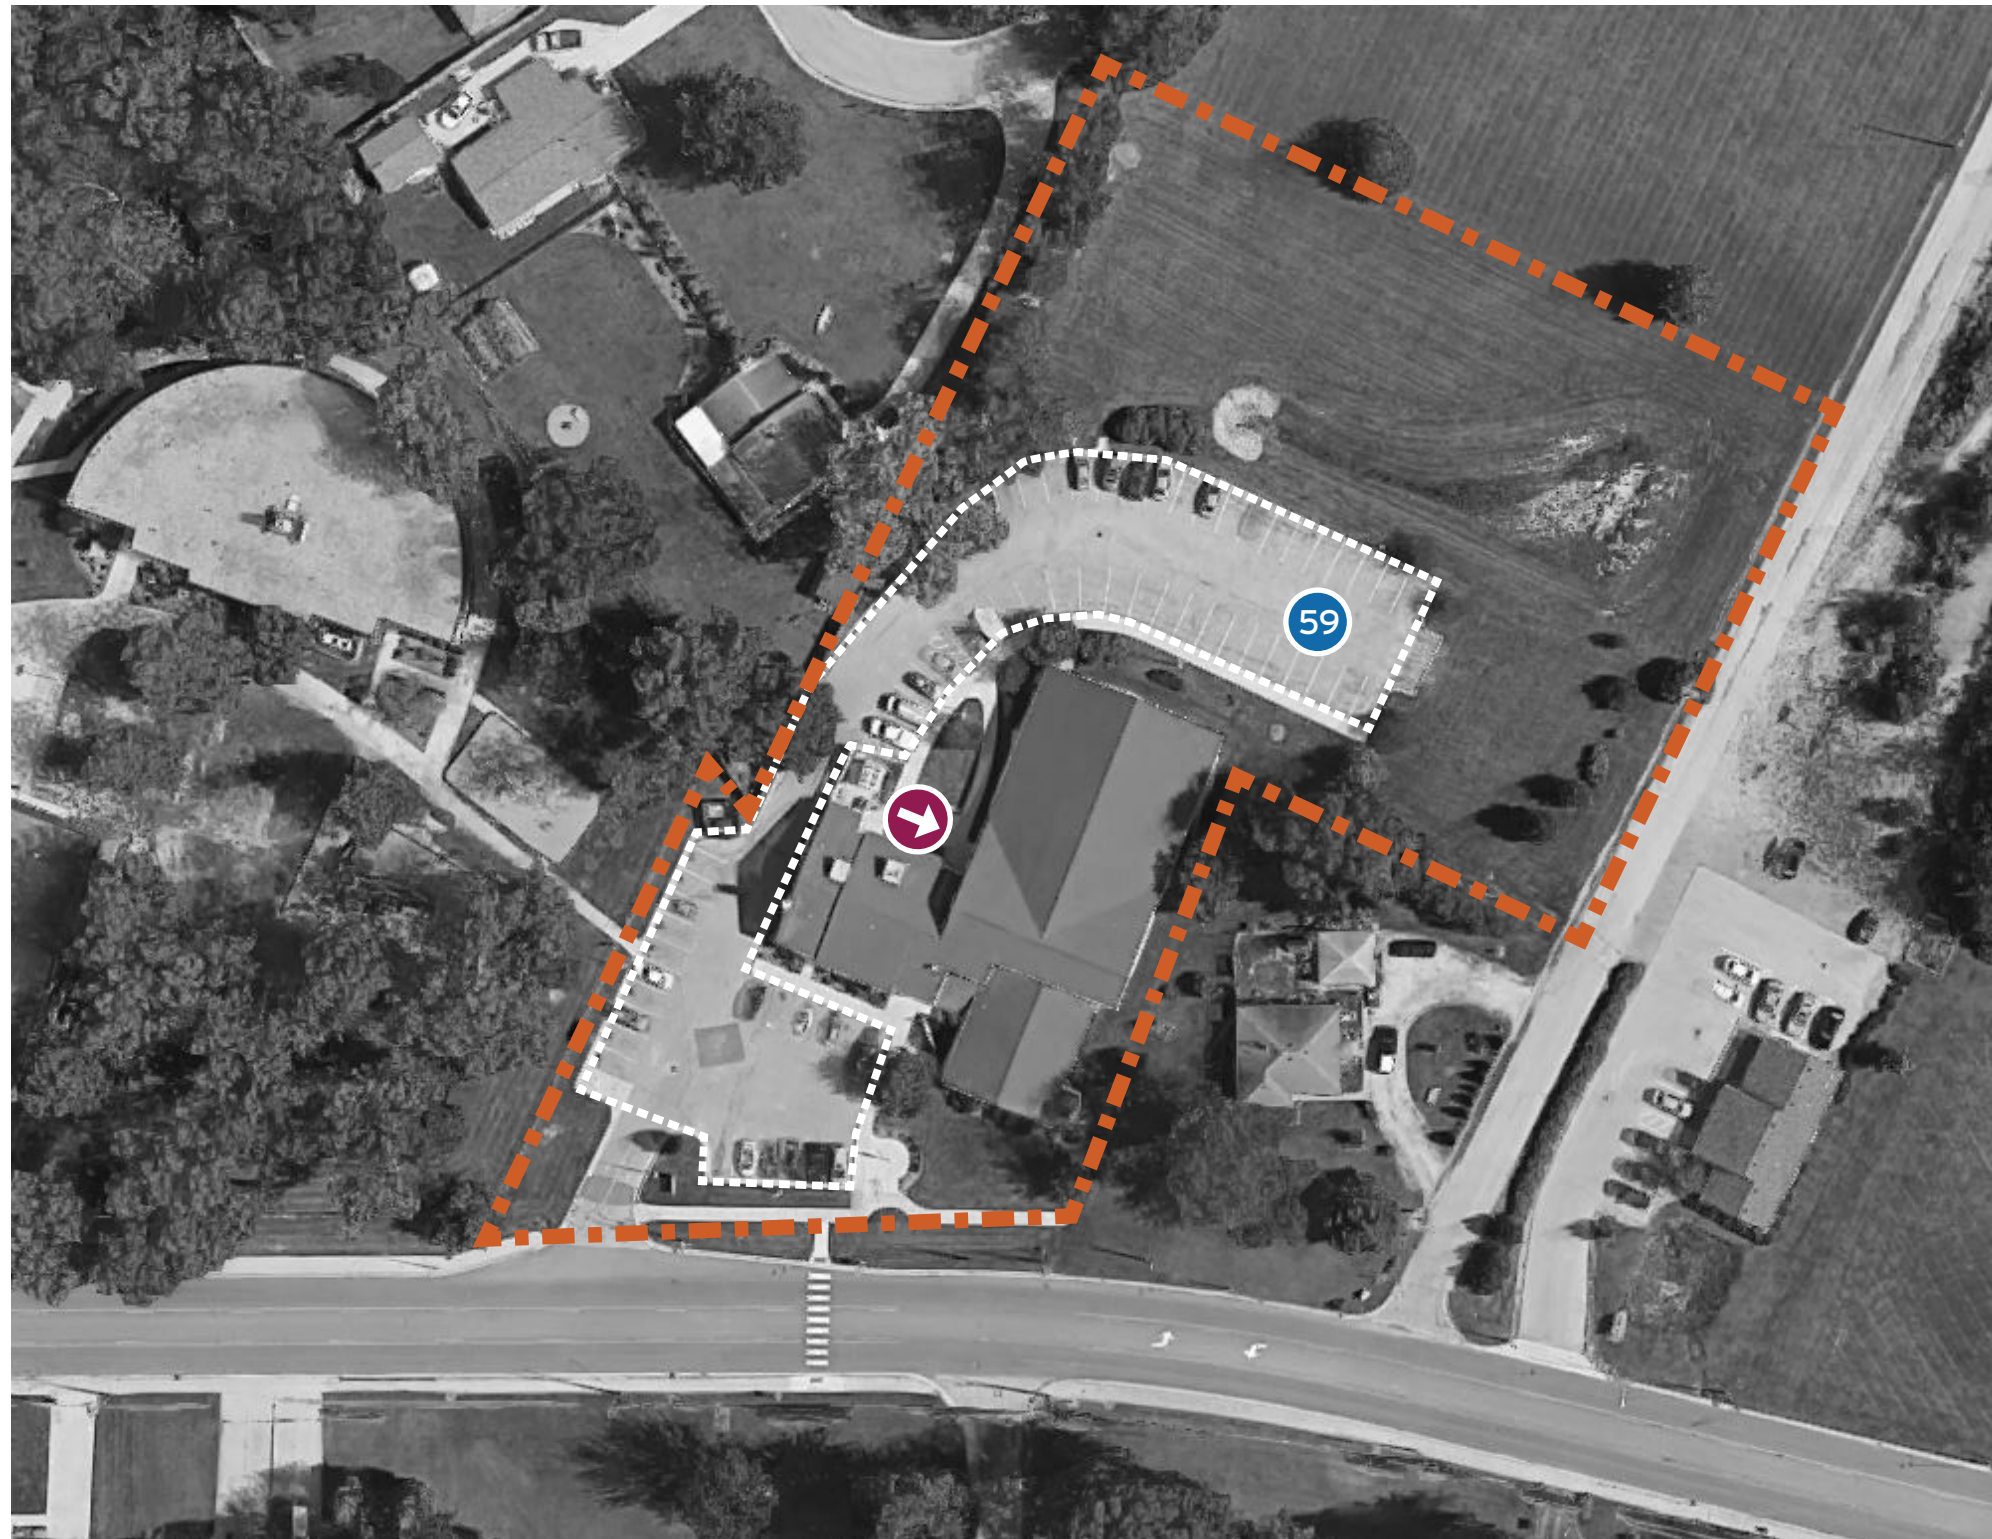
Site Plan

The branch and library sign are easily visible from Lower Huntington Road, a primary route in the area. The building is close to the street at the southeast corner but does not project a significant presence as a library.

The parking lot includes 59 total spaces, split between the front and back of the branch with 21 to the south (front) and 38 to the north (back).

The front lot is easily accessed and obvious from the street, although the entrance drive is narrow and seen as a collision hazard. The front lot includes four accessible parking spaces, however the ramp to access the building is inappropriately placed to the south of and well behind all the ADA spaces. It is not obvious that the back parking lot can also be used by library patrons.

There are no overhangs at either entrance to shield patrons from weather or winter ice build-up. The north facing entrance is convenient to the back parking lot, but a long walk to the entrance.

A wood fence along the neighboring yard to the west needs repair.

The site is generous and has ample green space to the north. Exterior spaces have not been developed for library programming.

The property could support expansion, although the architectural design and layout does not lend itself to easy expansion.
