Allen County Public Library

Facilities Master Plan

7 April 2022

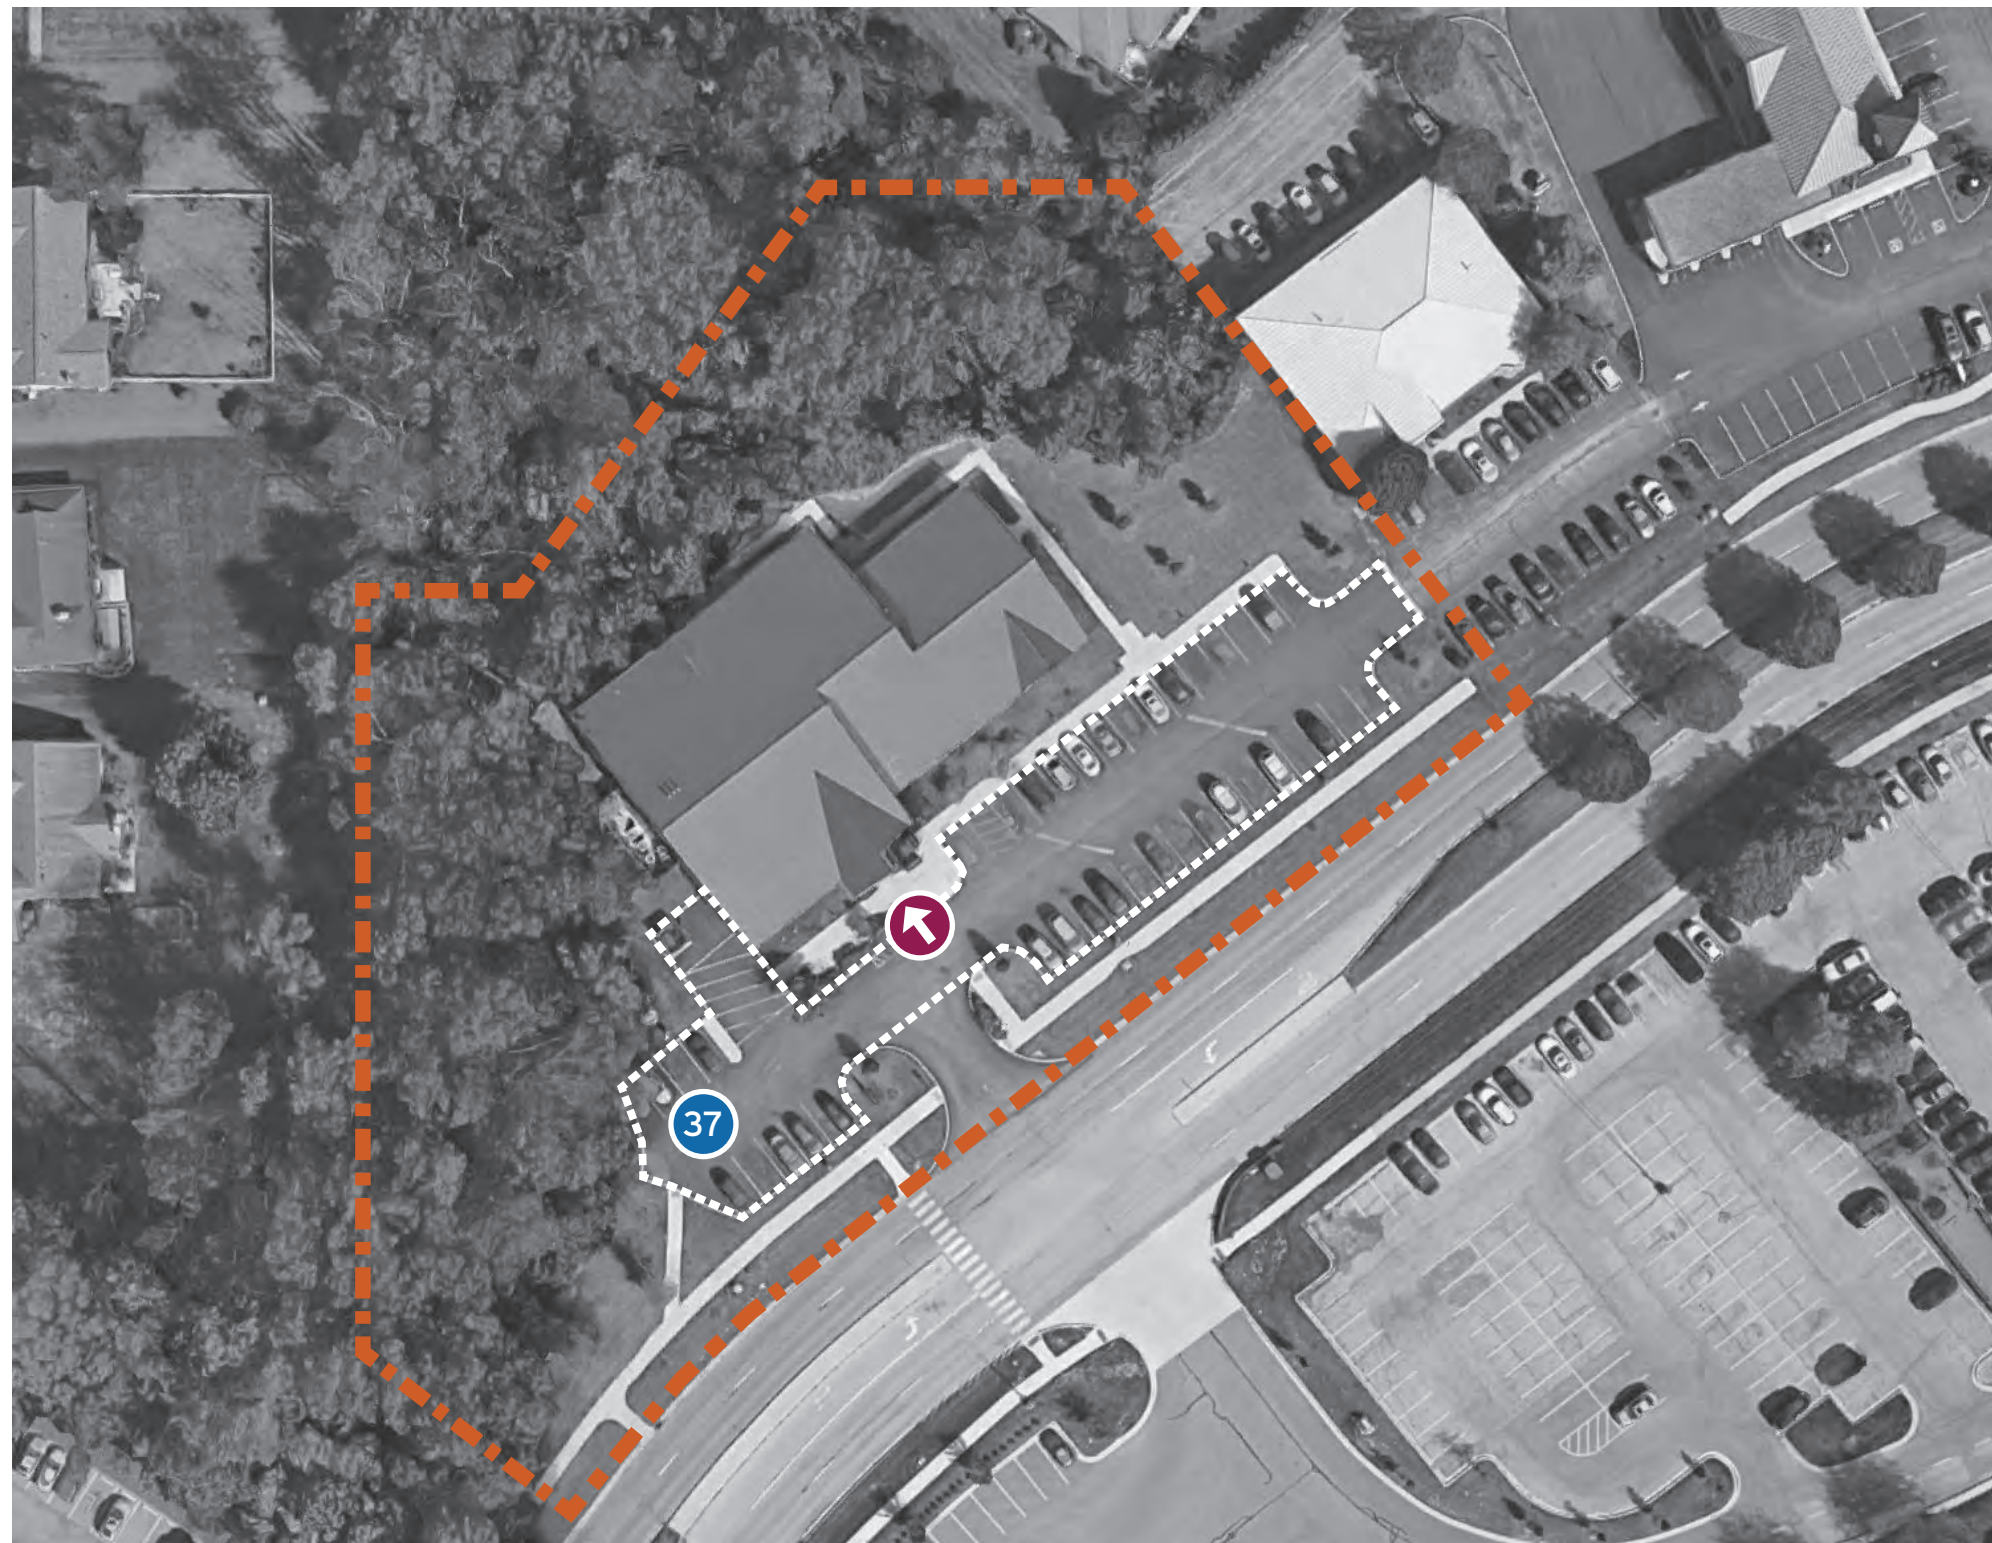
Site Plan

The parking lot is too small, and the configuration at a busy retail development requires overflow parking at adjacent lots across Coventry Lane requiring a hazardous street crossing to access the branch.

The site has a small grass yard to the north, but not sufficient for programming or expansion. The ravine to the south and west of the branch further limit any growth or development.

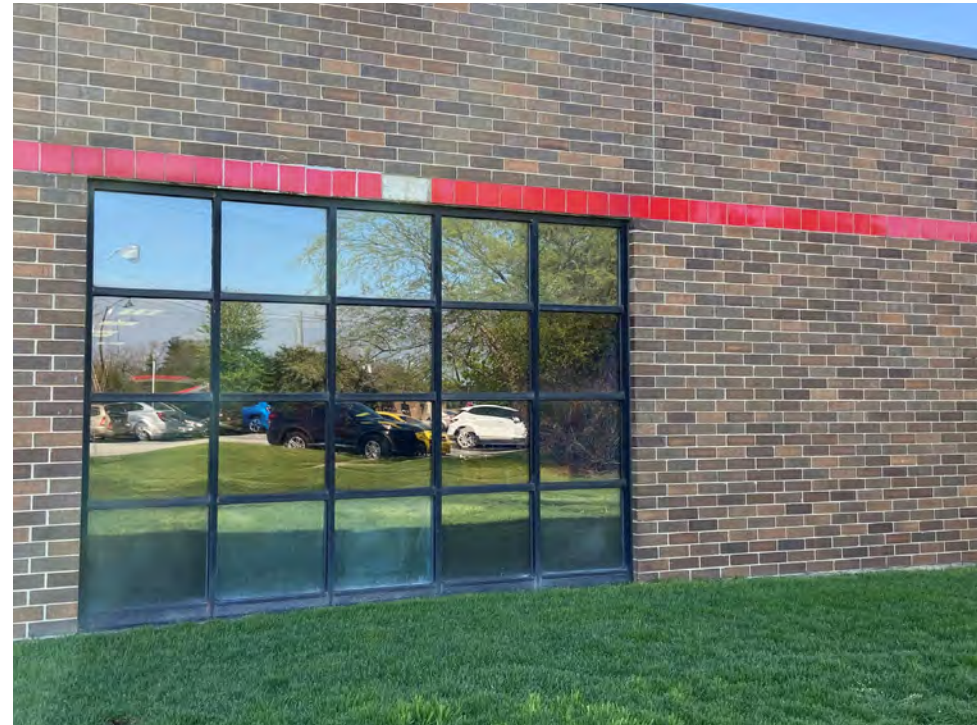
- The building envelope is generally in fair shape and has been well maintained.
- Red exterior decorative tile has cracked and fallen off in a few places on the N and NW facades, an aesthetic and minor weather barrier concern to be corrected.
- Roof repairs were completed within the last 5 years, however staff indicated roof leaks remain an issue. The skylight dates to the original construction and contributes to the roofing and leak concerns.
- Many finish materials are original to the expansion. Furniture and equipment are a mix of old and newer.
- The original building pre-dates the Americans with Disabilities Act, and a survey prepared by Huntington University identified conditions that are non-compliant with the current applicable law.

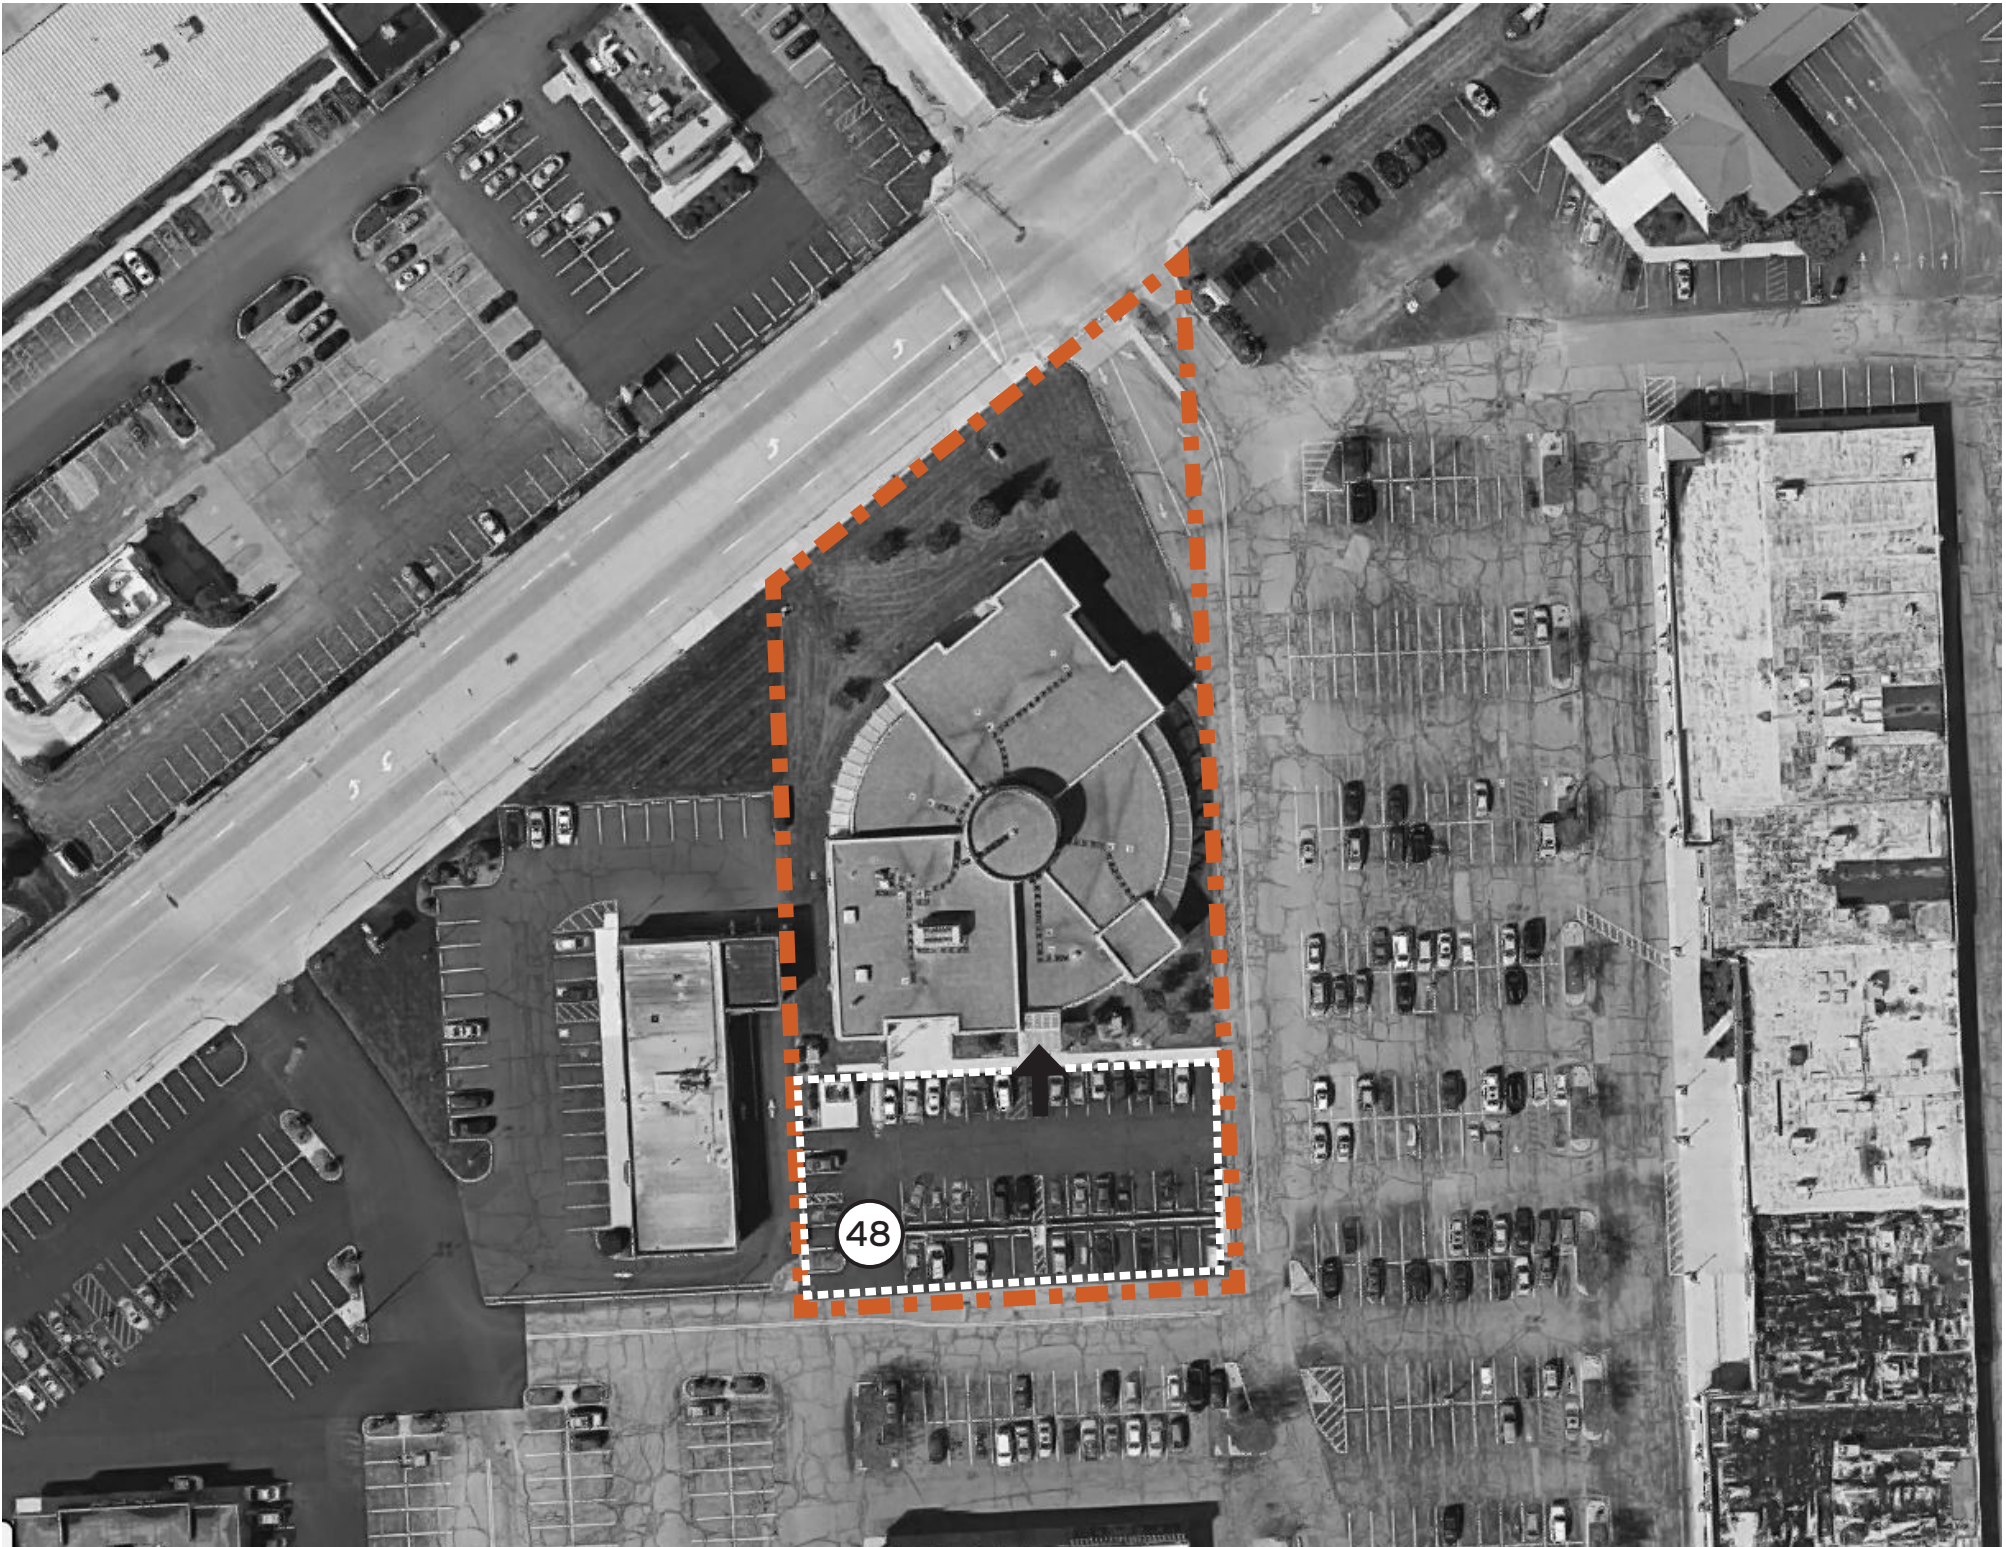
Site Plan

The parking lot is small and challenging to navigate, and the largest concern to survey respondents. The configuration and access from a busy retail development can be hazardous given competition with non-library traffic, including the difficulty of access from the lower level of parking on the south side of the site. The lot includes only one dedicated ADA spot, inadequate for this site.

After school the exterior and entrance area become overcrowded with school age patrons, creating noise, congestion, and hazards with arriving and departing vehicles. There are no sidewalks for students to walk safely.

The property has no viable space for any significant building expansion. A possibility exists to enclose spaces under the sunshades along curved sections of the building, which could add minimal square footage but at a relatively high cost.

The location of the materials drop is hard to find

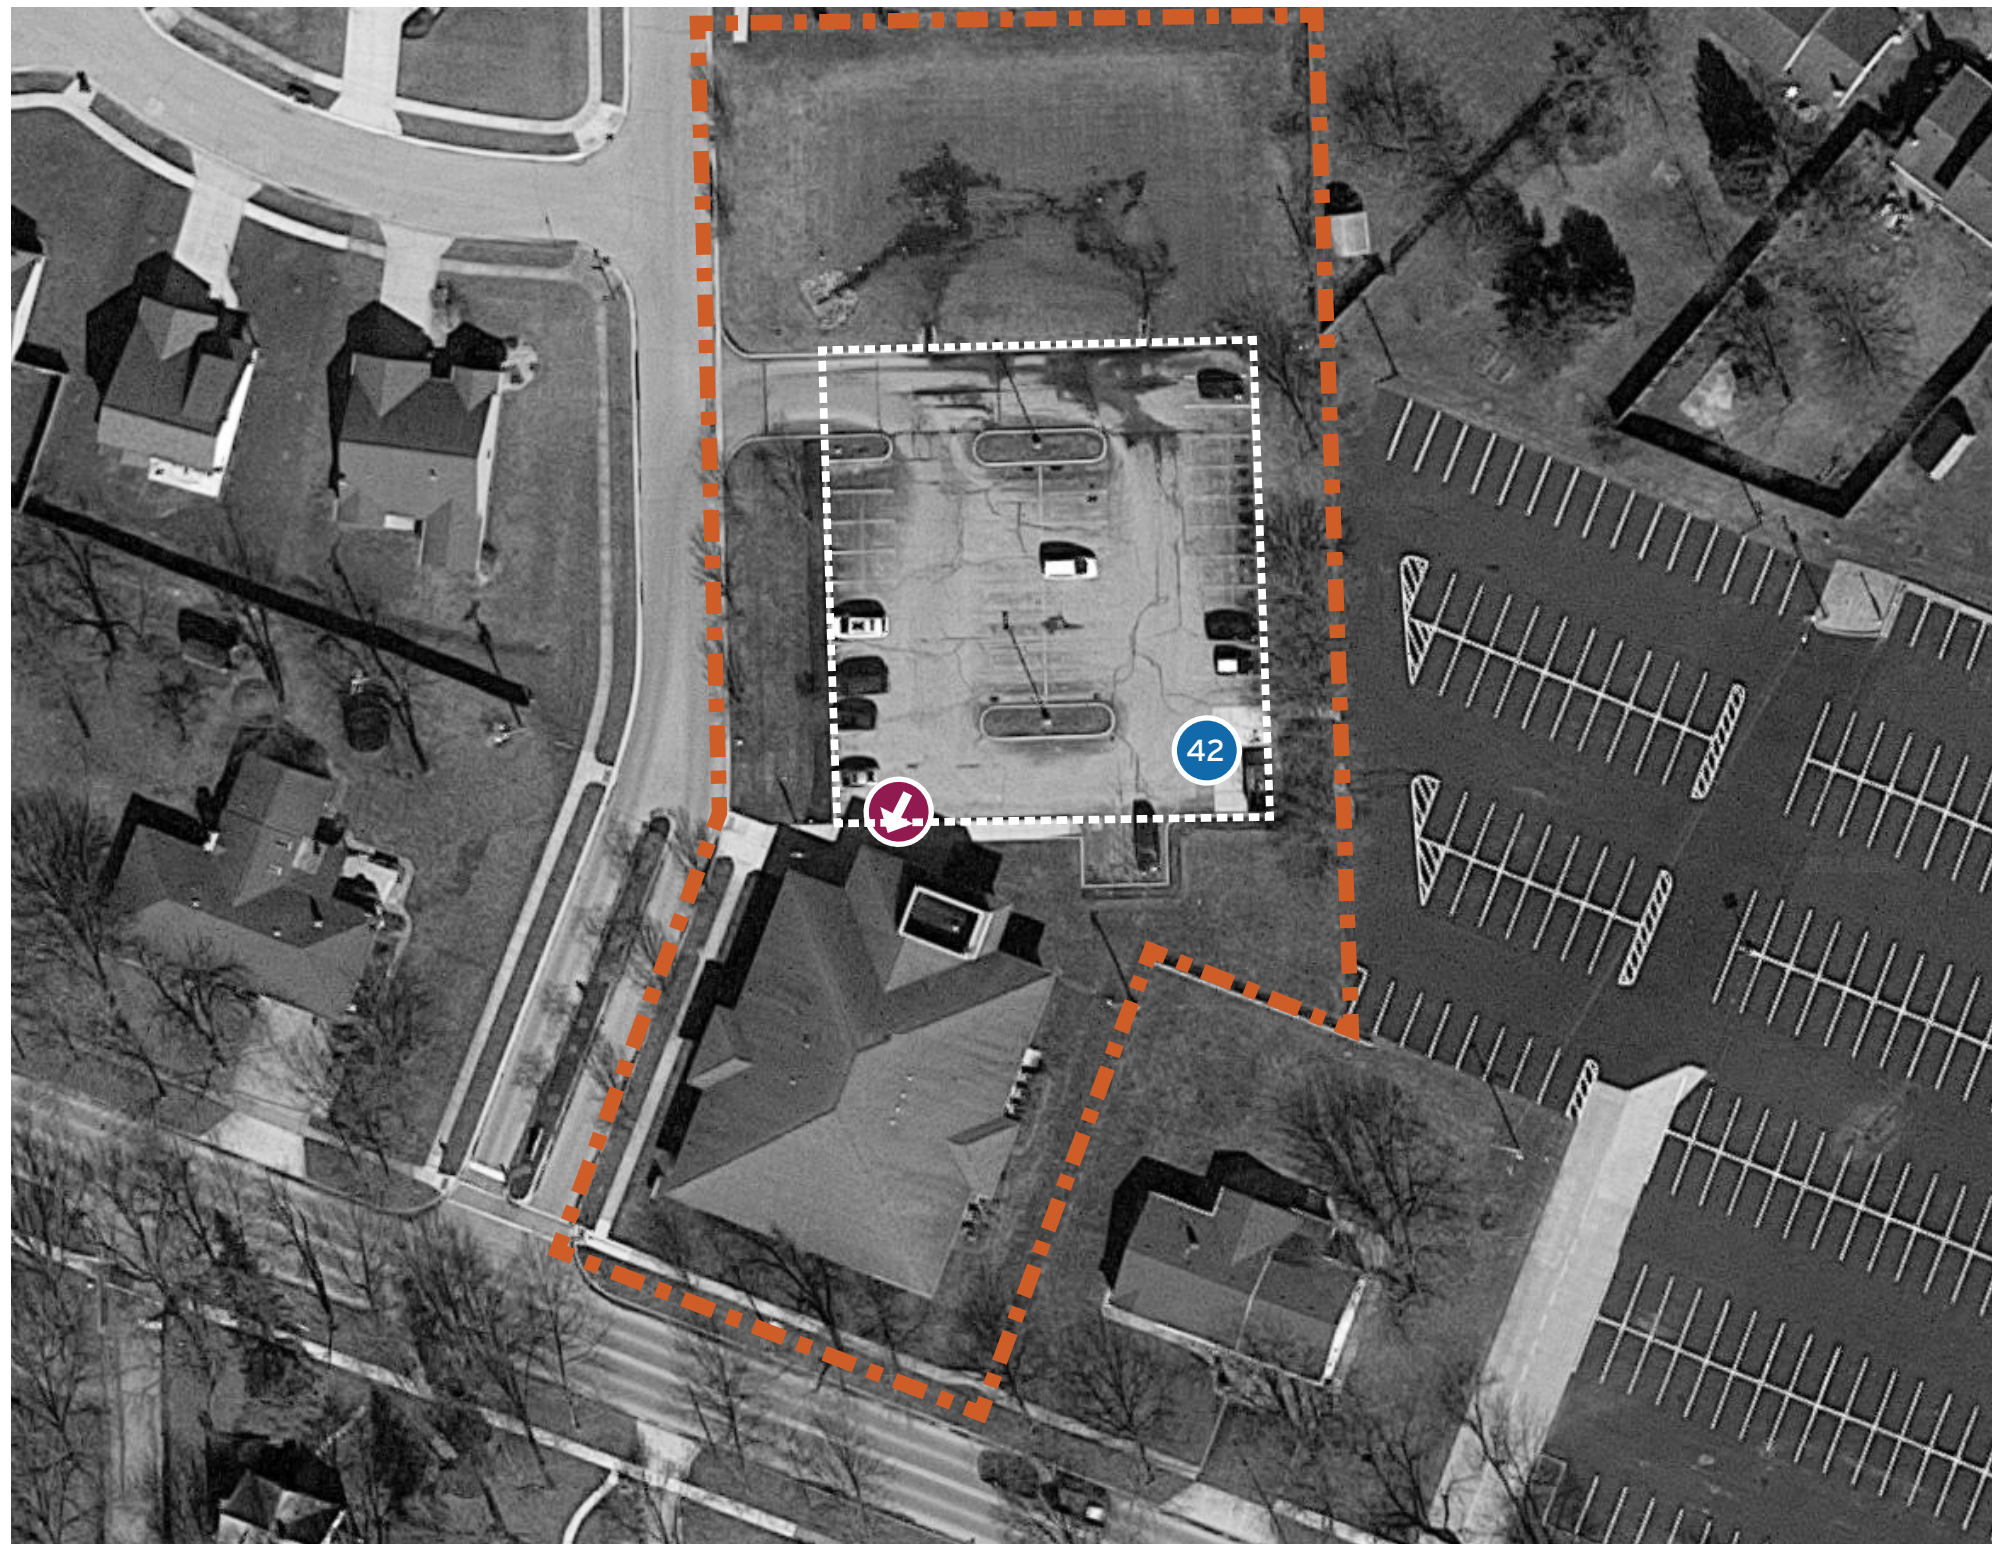
The branch has good visibility from Grabill Road, and the building design projects some presence as a library in a mixed but mostly residential part of Grabill just west of downtown. Parking is accessed off Grabill Road via Illinois Street immediately west of the library. The lot includes 42 spaces, a capacity that was not noted as a concern for the library.

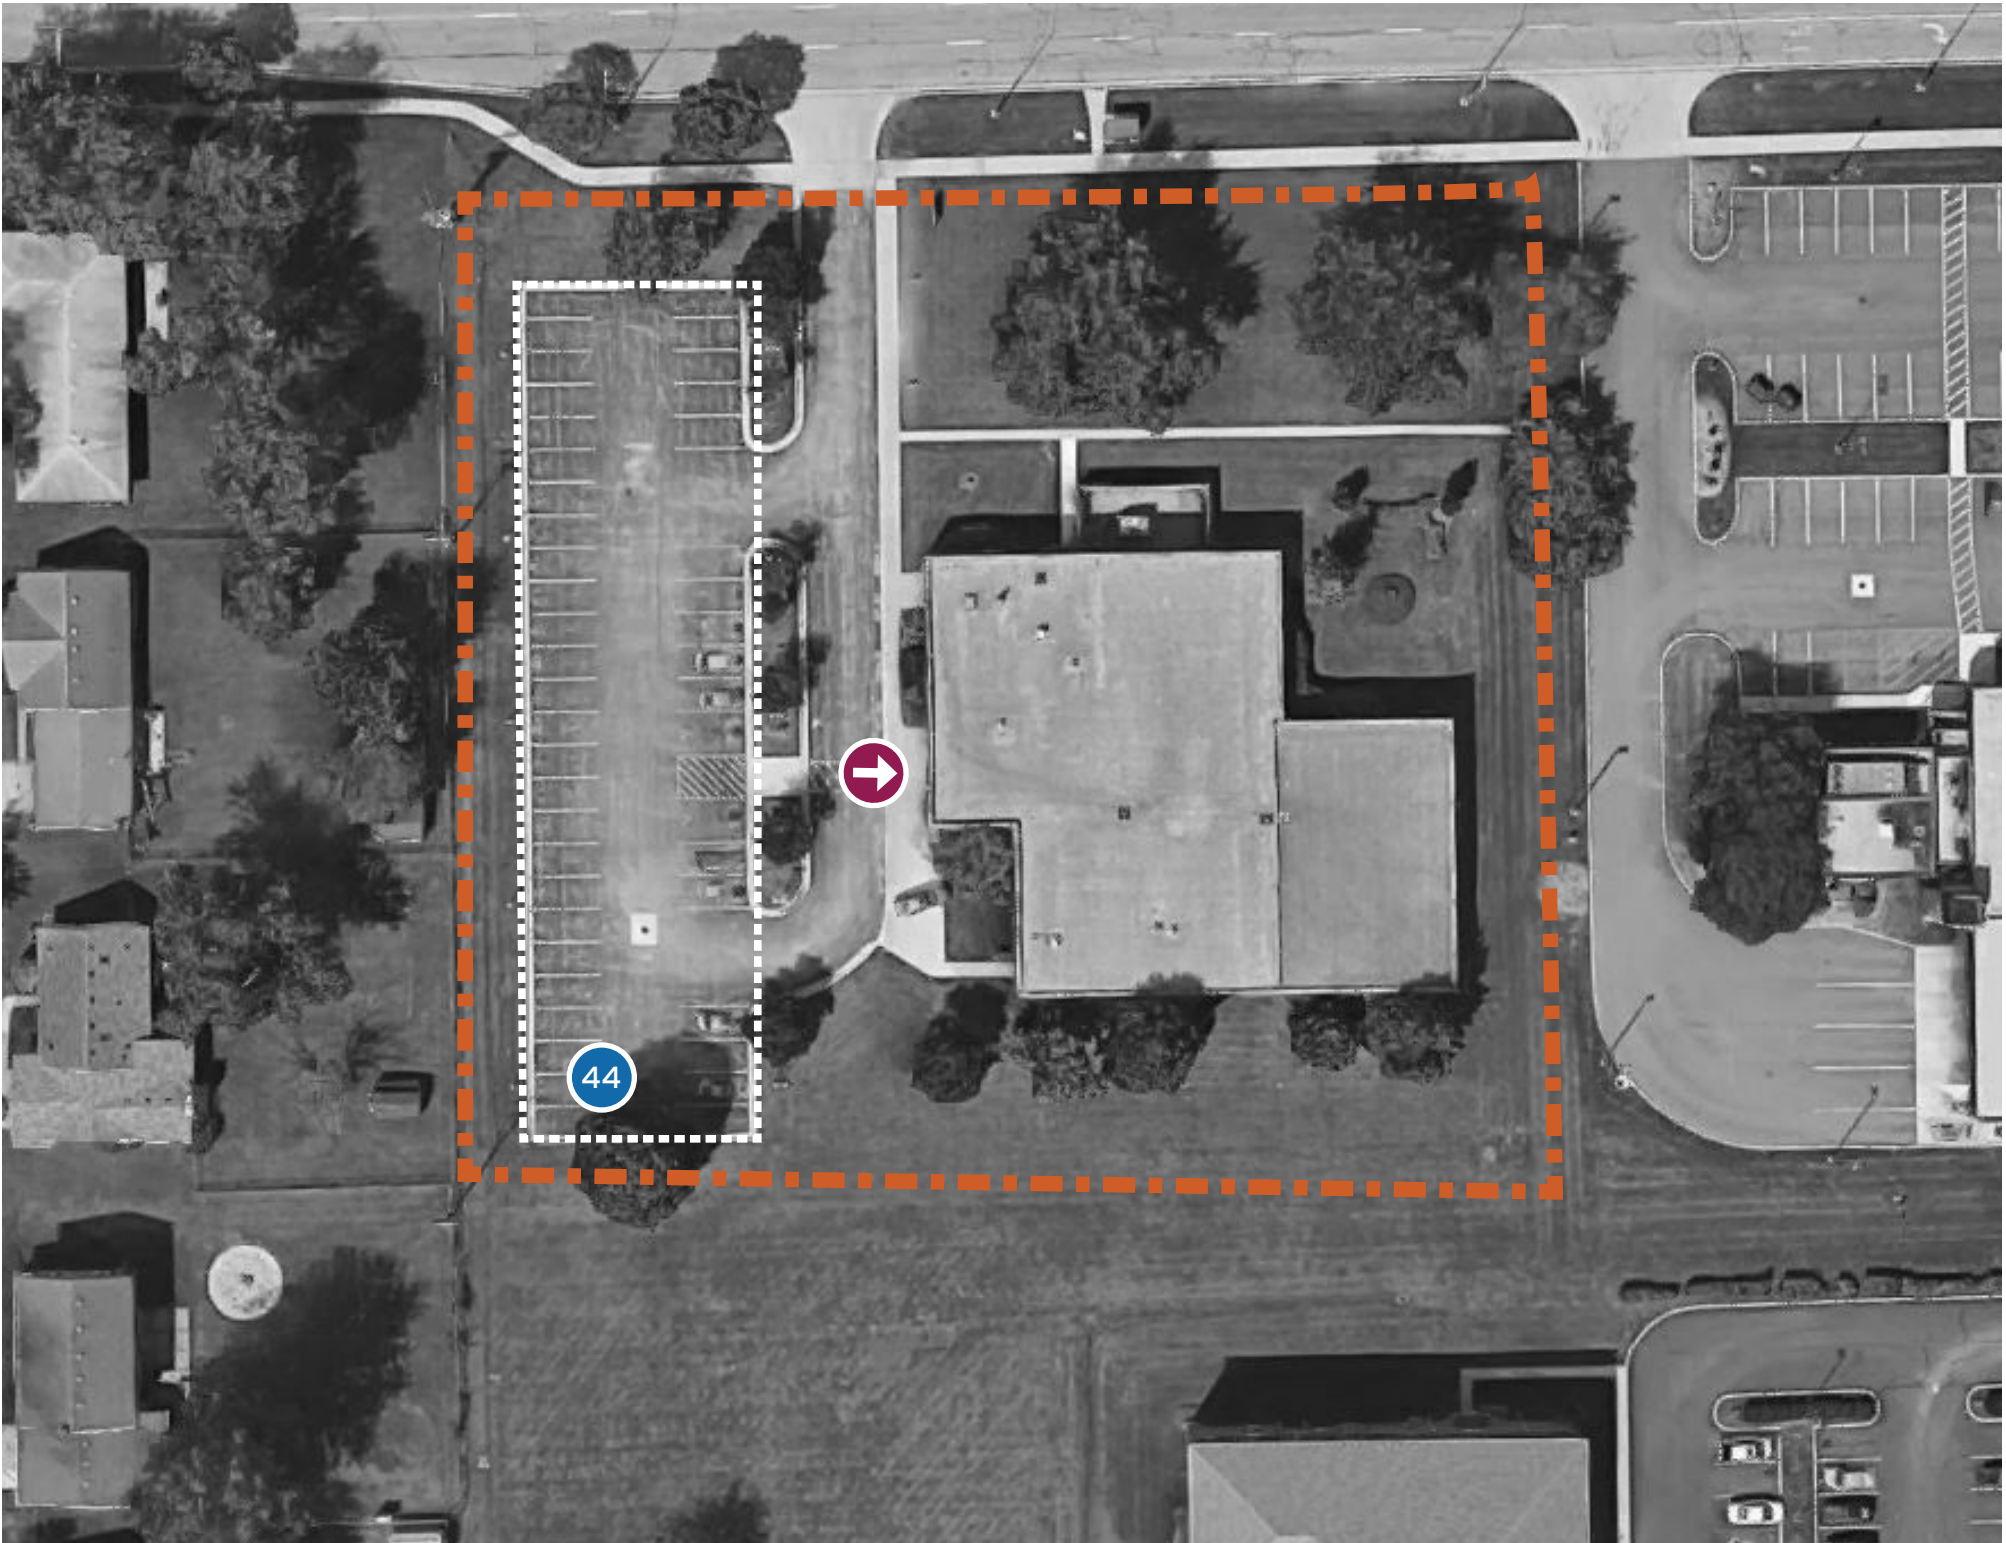
The site includes green space that could easily be improved for exterior programming or outdoor seating for library patrons.

The property could accommodate expansion in several locations, and original drawings specifically noted expansion capability to the south.

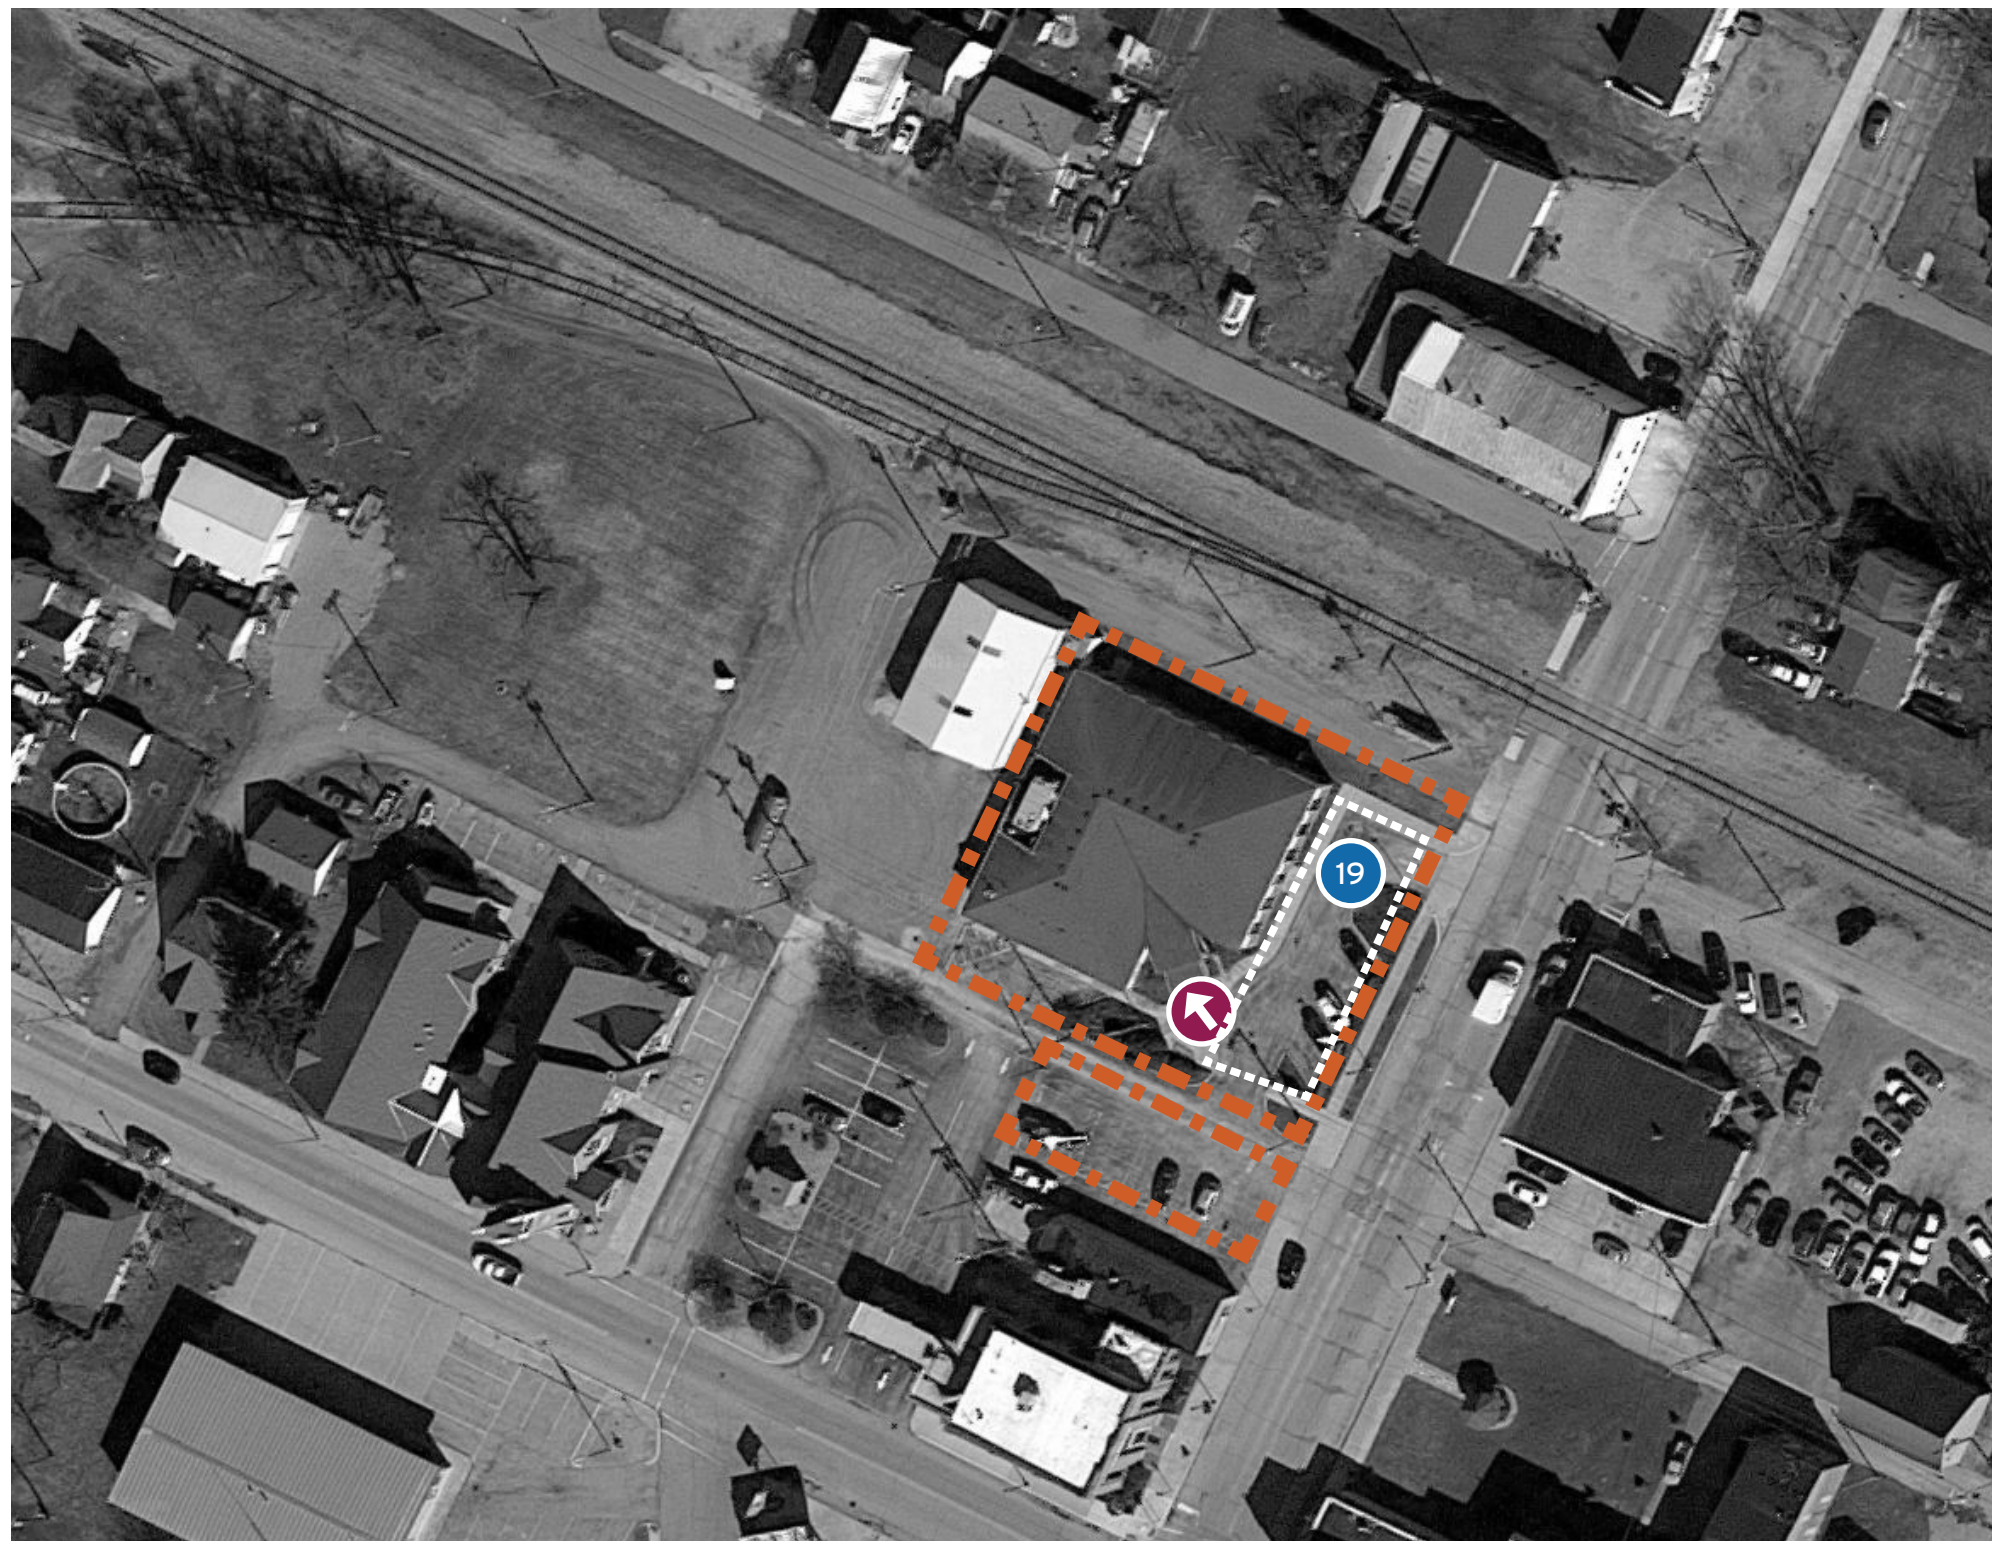
The property lines are very tight to the building, and they could not accommodate any expansion.

The exterior book return is on the south side of the building and not obvious to visitors.

main entrance
	number of parking spaces
	property line

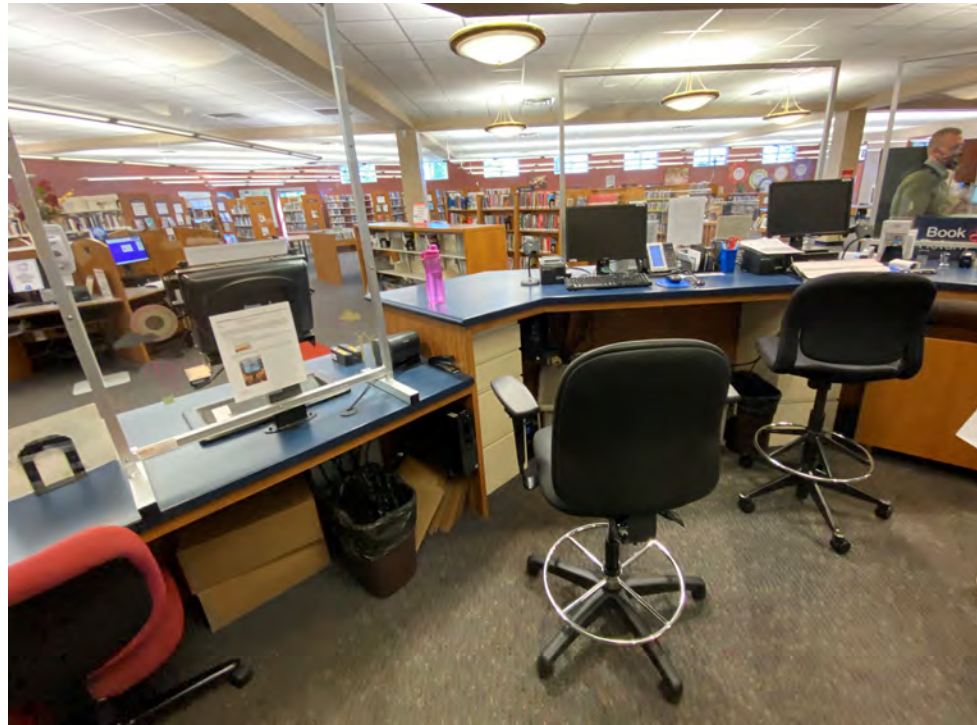
FUNCTIONALITY

Monroeville is small, but it is adequately sized for the community served and volume of use.

- The space previously dedicated to vending should be remodeled to accommodate library service functions.
- The young adult space is small and not acoustically separated from the rest of the space. The volume of teens is low given there are other spaces in the area that support teen programming.

- A small study room and adjacent computer room are adequately designed but not optimally located since they adjacent to the children's area.
- The layout of the branch does not adequately separate quiet and loud spaces.

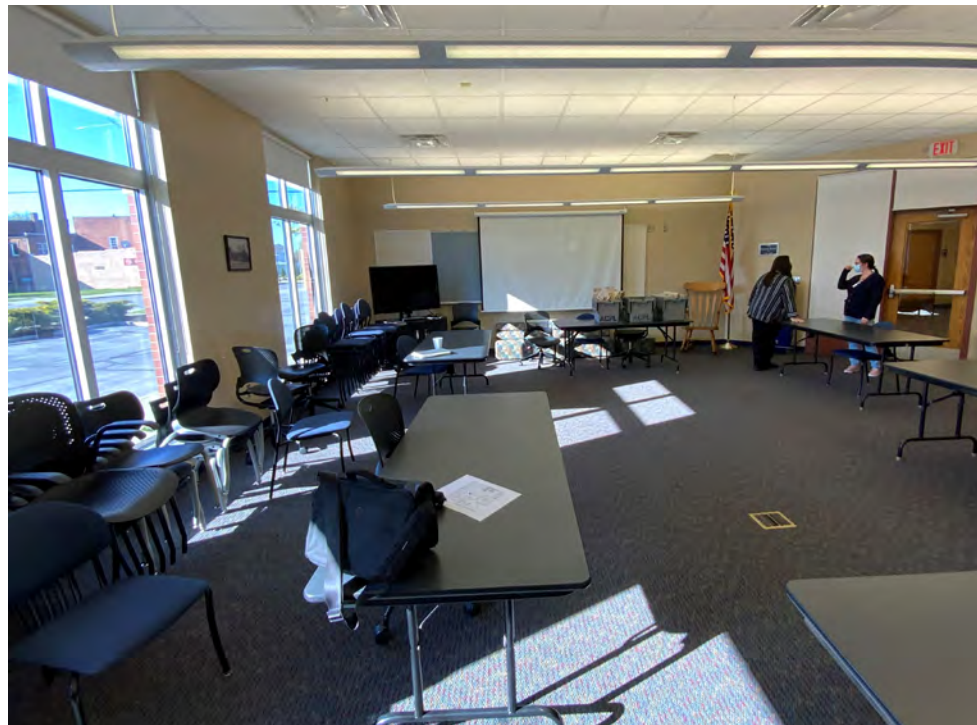
EFFICIENCY

- The circulation service point is large for the building but in good condition and provides good sight lines. The view from the desk to the vestibule and front door is a plus.
- The staff work area access point is too close to the entrance which allows staff access to the building exit, but can create a bottleneck at the entry area.
- The branch manager office is in good proximity to staff work areas and good views to the branch, but not convenient to help patrons.
- The staff work area is small but adequate for the current number of staff, however there is a lack of storage.
- The open book return directly into the work space should be enclosed for sound and safety.

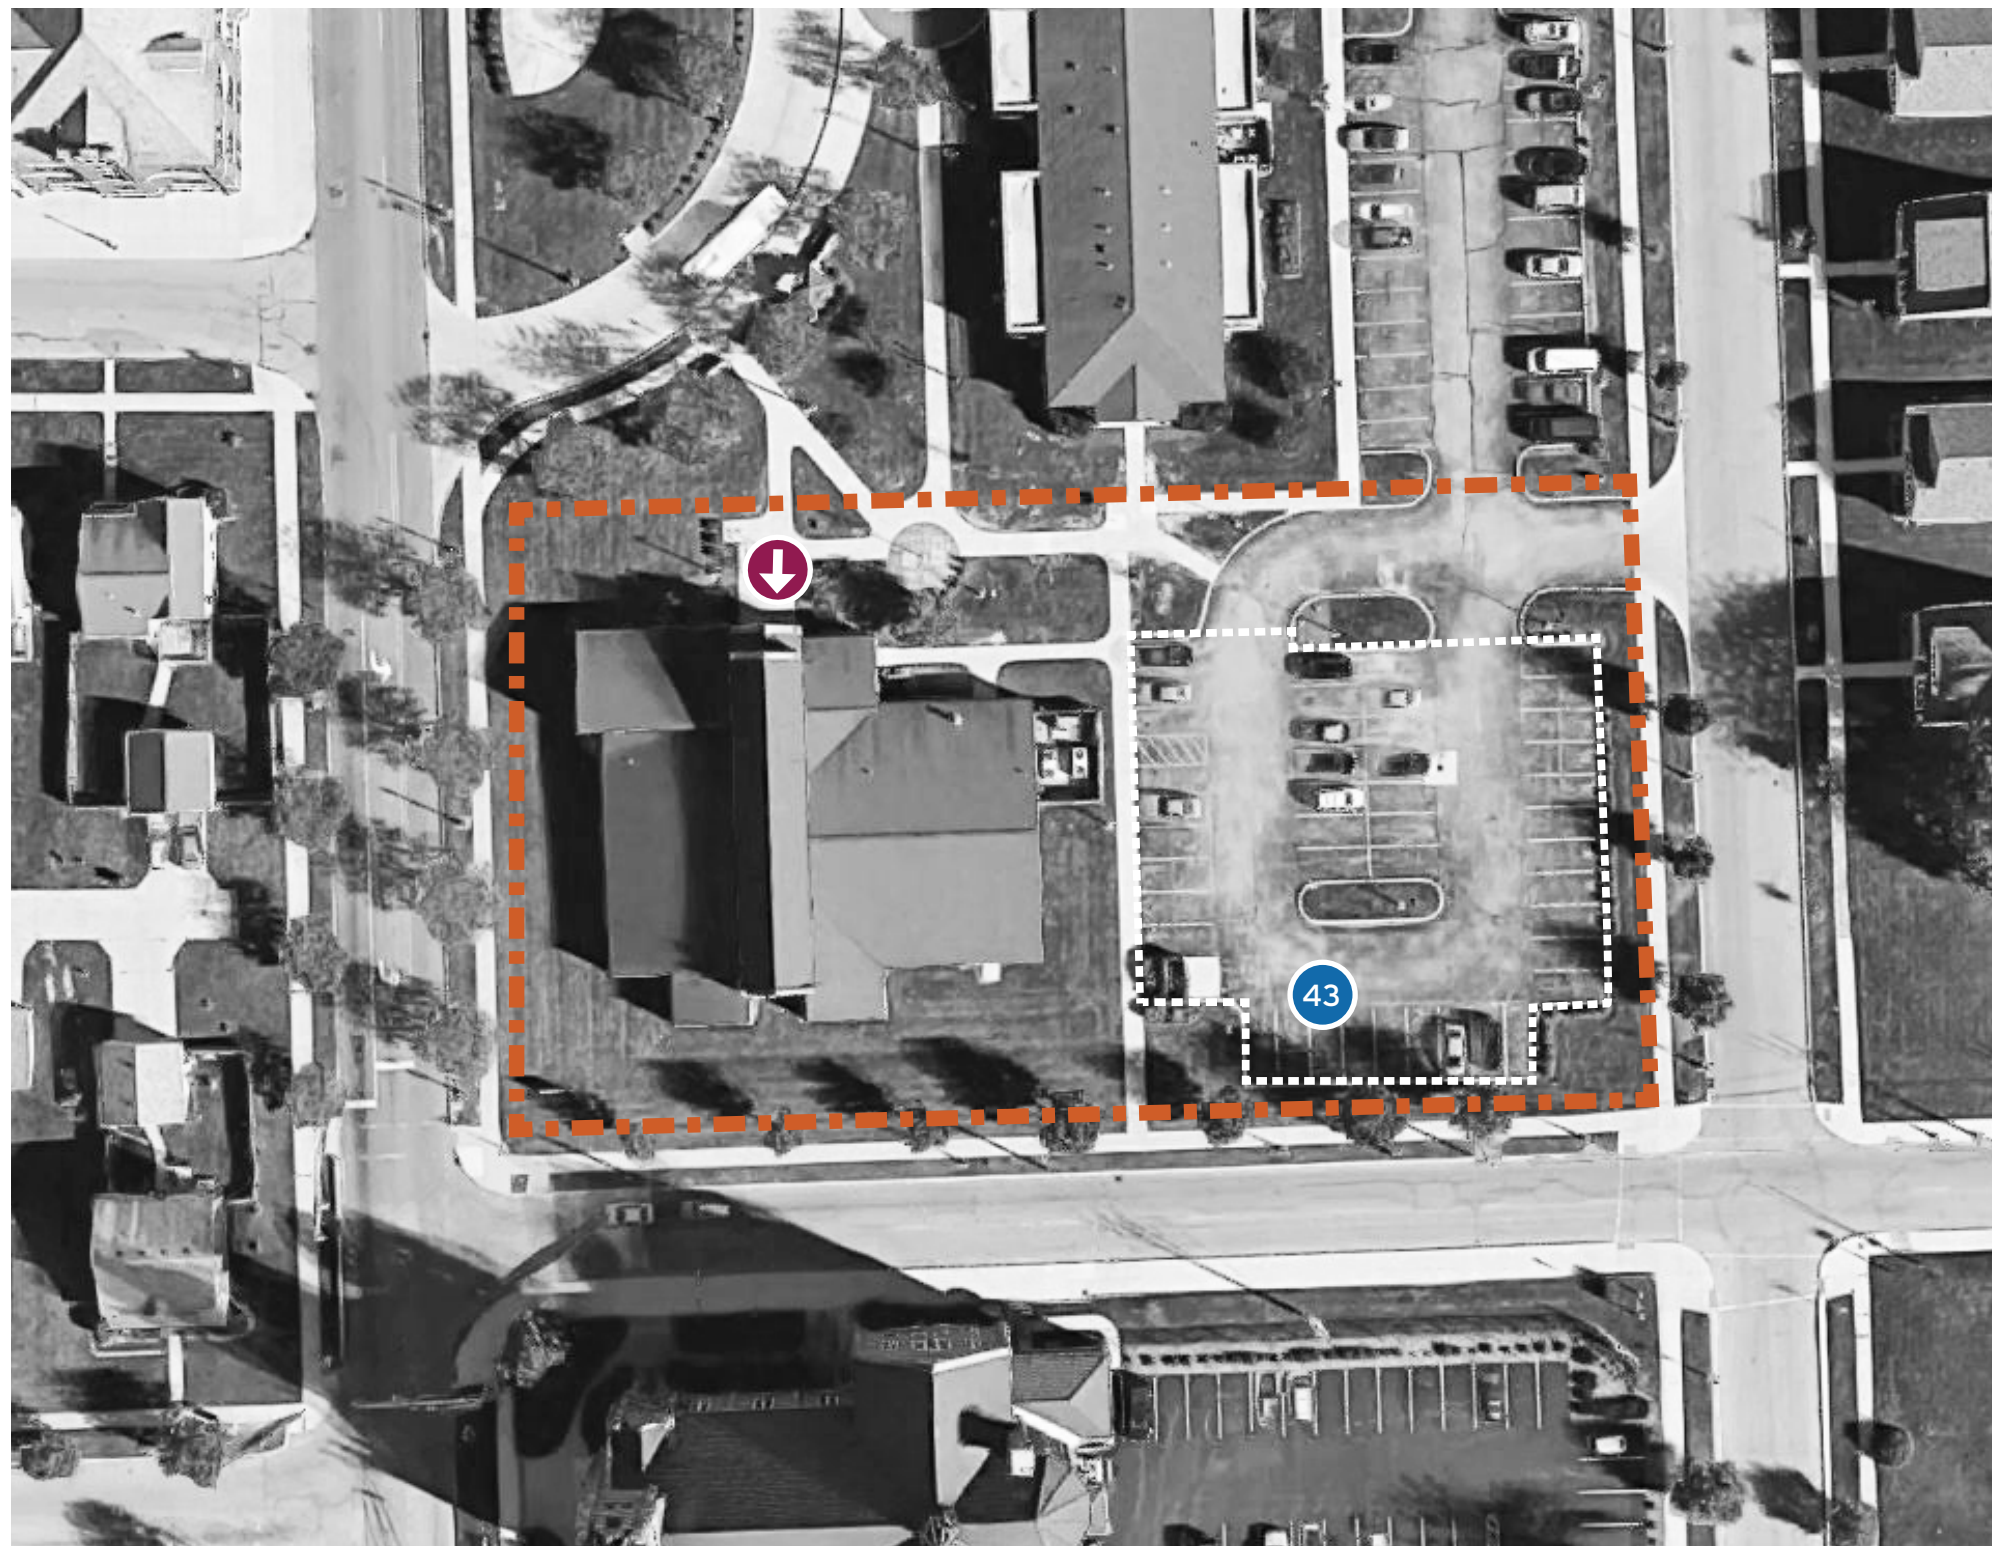
main entrance
	number of parking spaces
	property line

The main entrance is close to a drop-off drive to the north that serves other buildings for bus traffic only. This causes confusion as that drive does not lead to library parking, but is close to the entrance and off of Hanna Street, the library's address. The distance from the parking lot to the entry is unusually far, and particularly difficult for those with mobility challenges and for all patrons during bad weather.

The site includes green space that could be developed to support outdoor programming. The site could accommodate a modest expansion of the building along the northeast and east walls.
