Allen County Public Library

Facilities Master Plan

7 April 2022

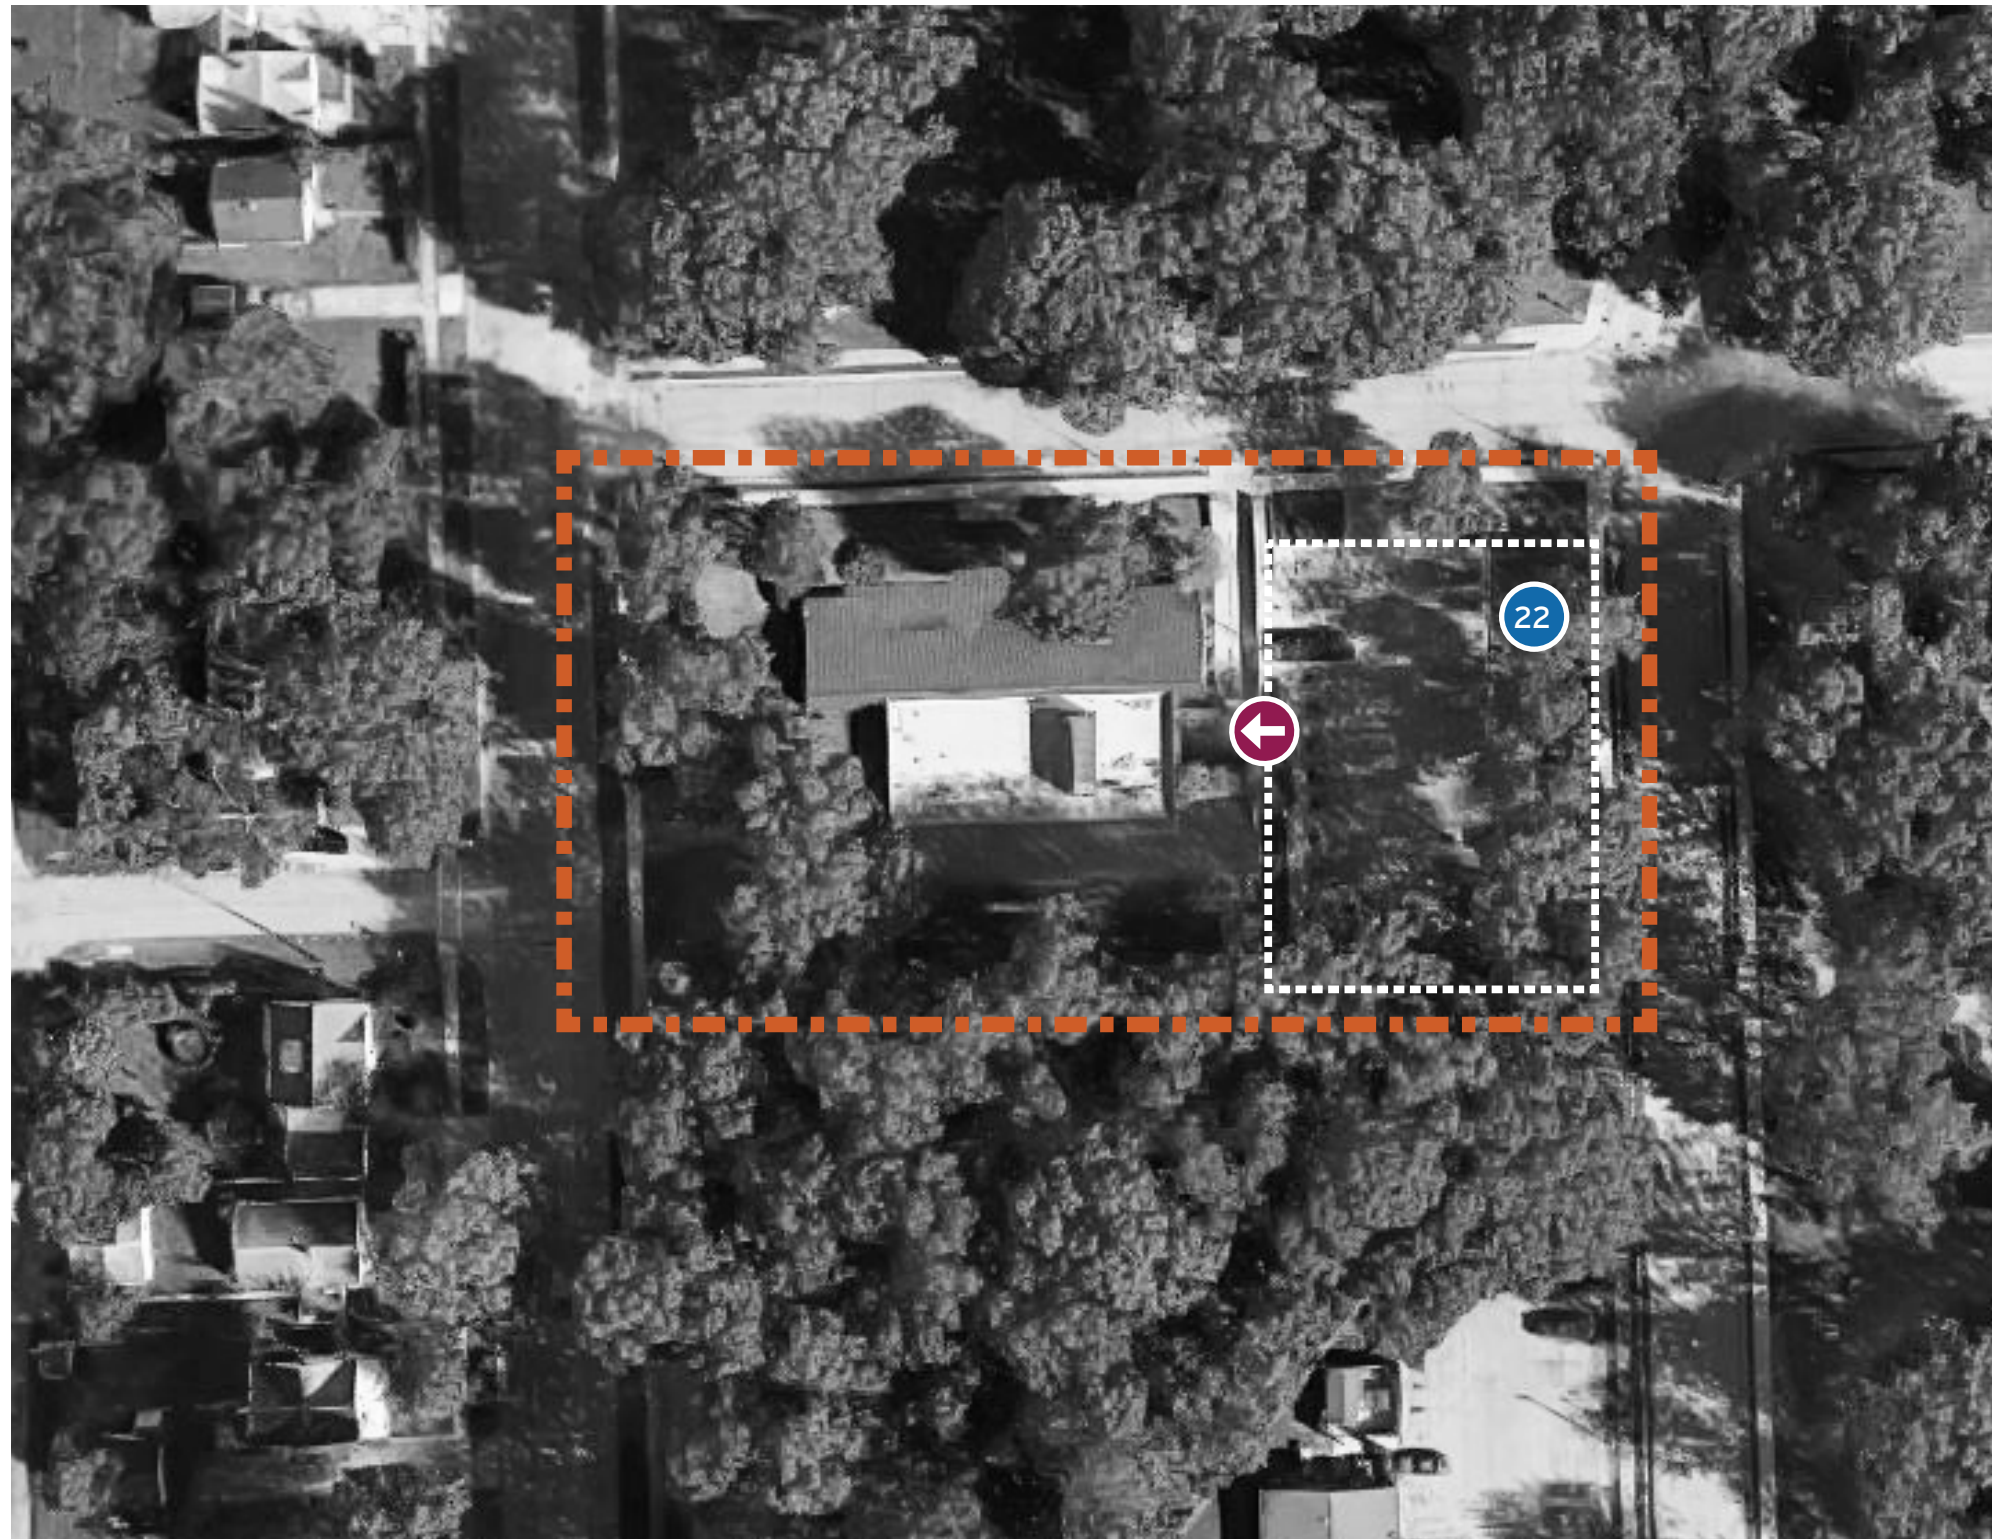
Site Plan

The parking limitations, level changes, and below-grade main entrance are all inadequate and are a barrier to access for this library. Accessible parking is provided but the ramp to access the main entrance is unacceptably long and can be dangerous in bad weather.

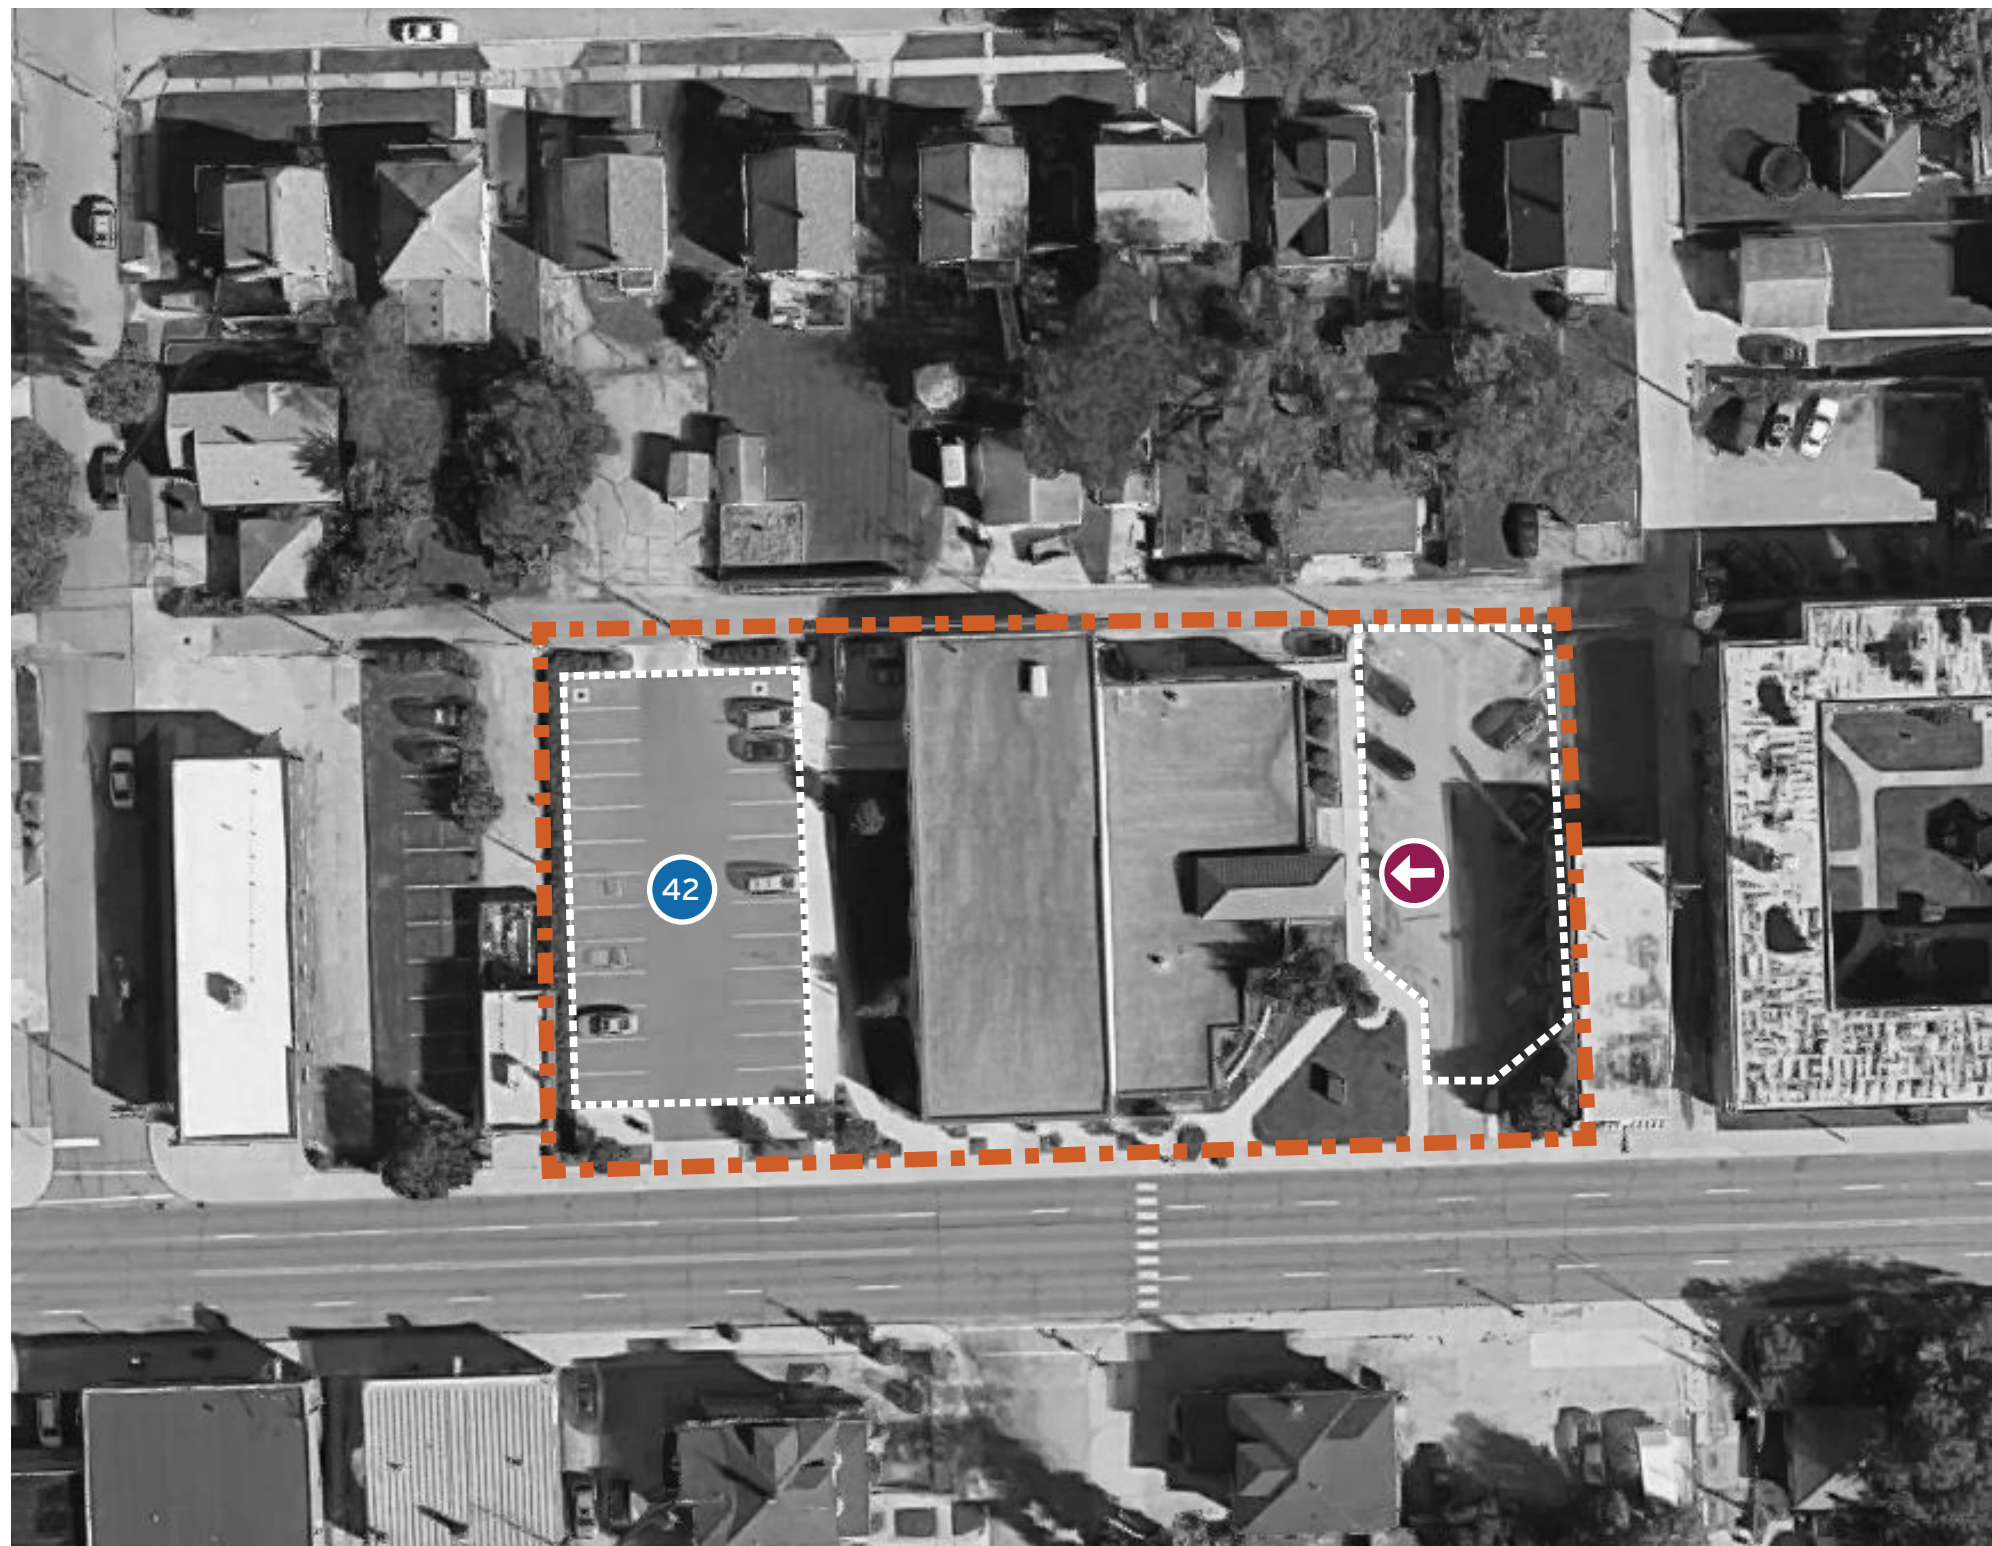
The site has some green space to the west and at the southeast corner near the entrance, some of which has been used for programming and is planned to be developed into a Pollinator Prairie Garden. The parking lot west of the building was designed specifically to support events.

The property is not large enough to support any significant expansion. Some modest renovation could occur near the entrance or along the west wall.

main entrance
	number of parking spaces
	property line

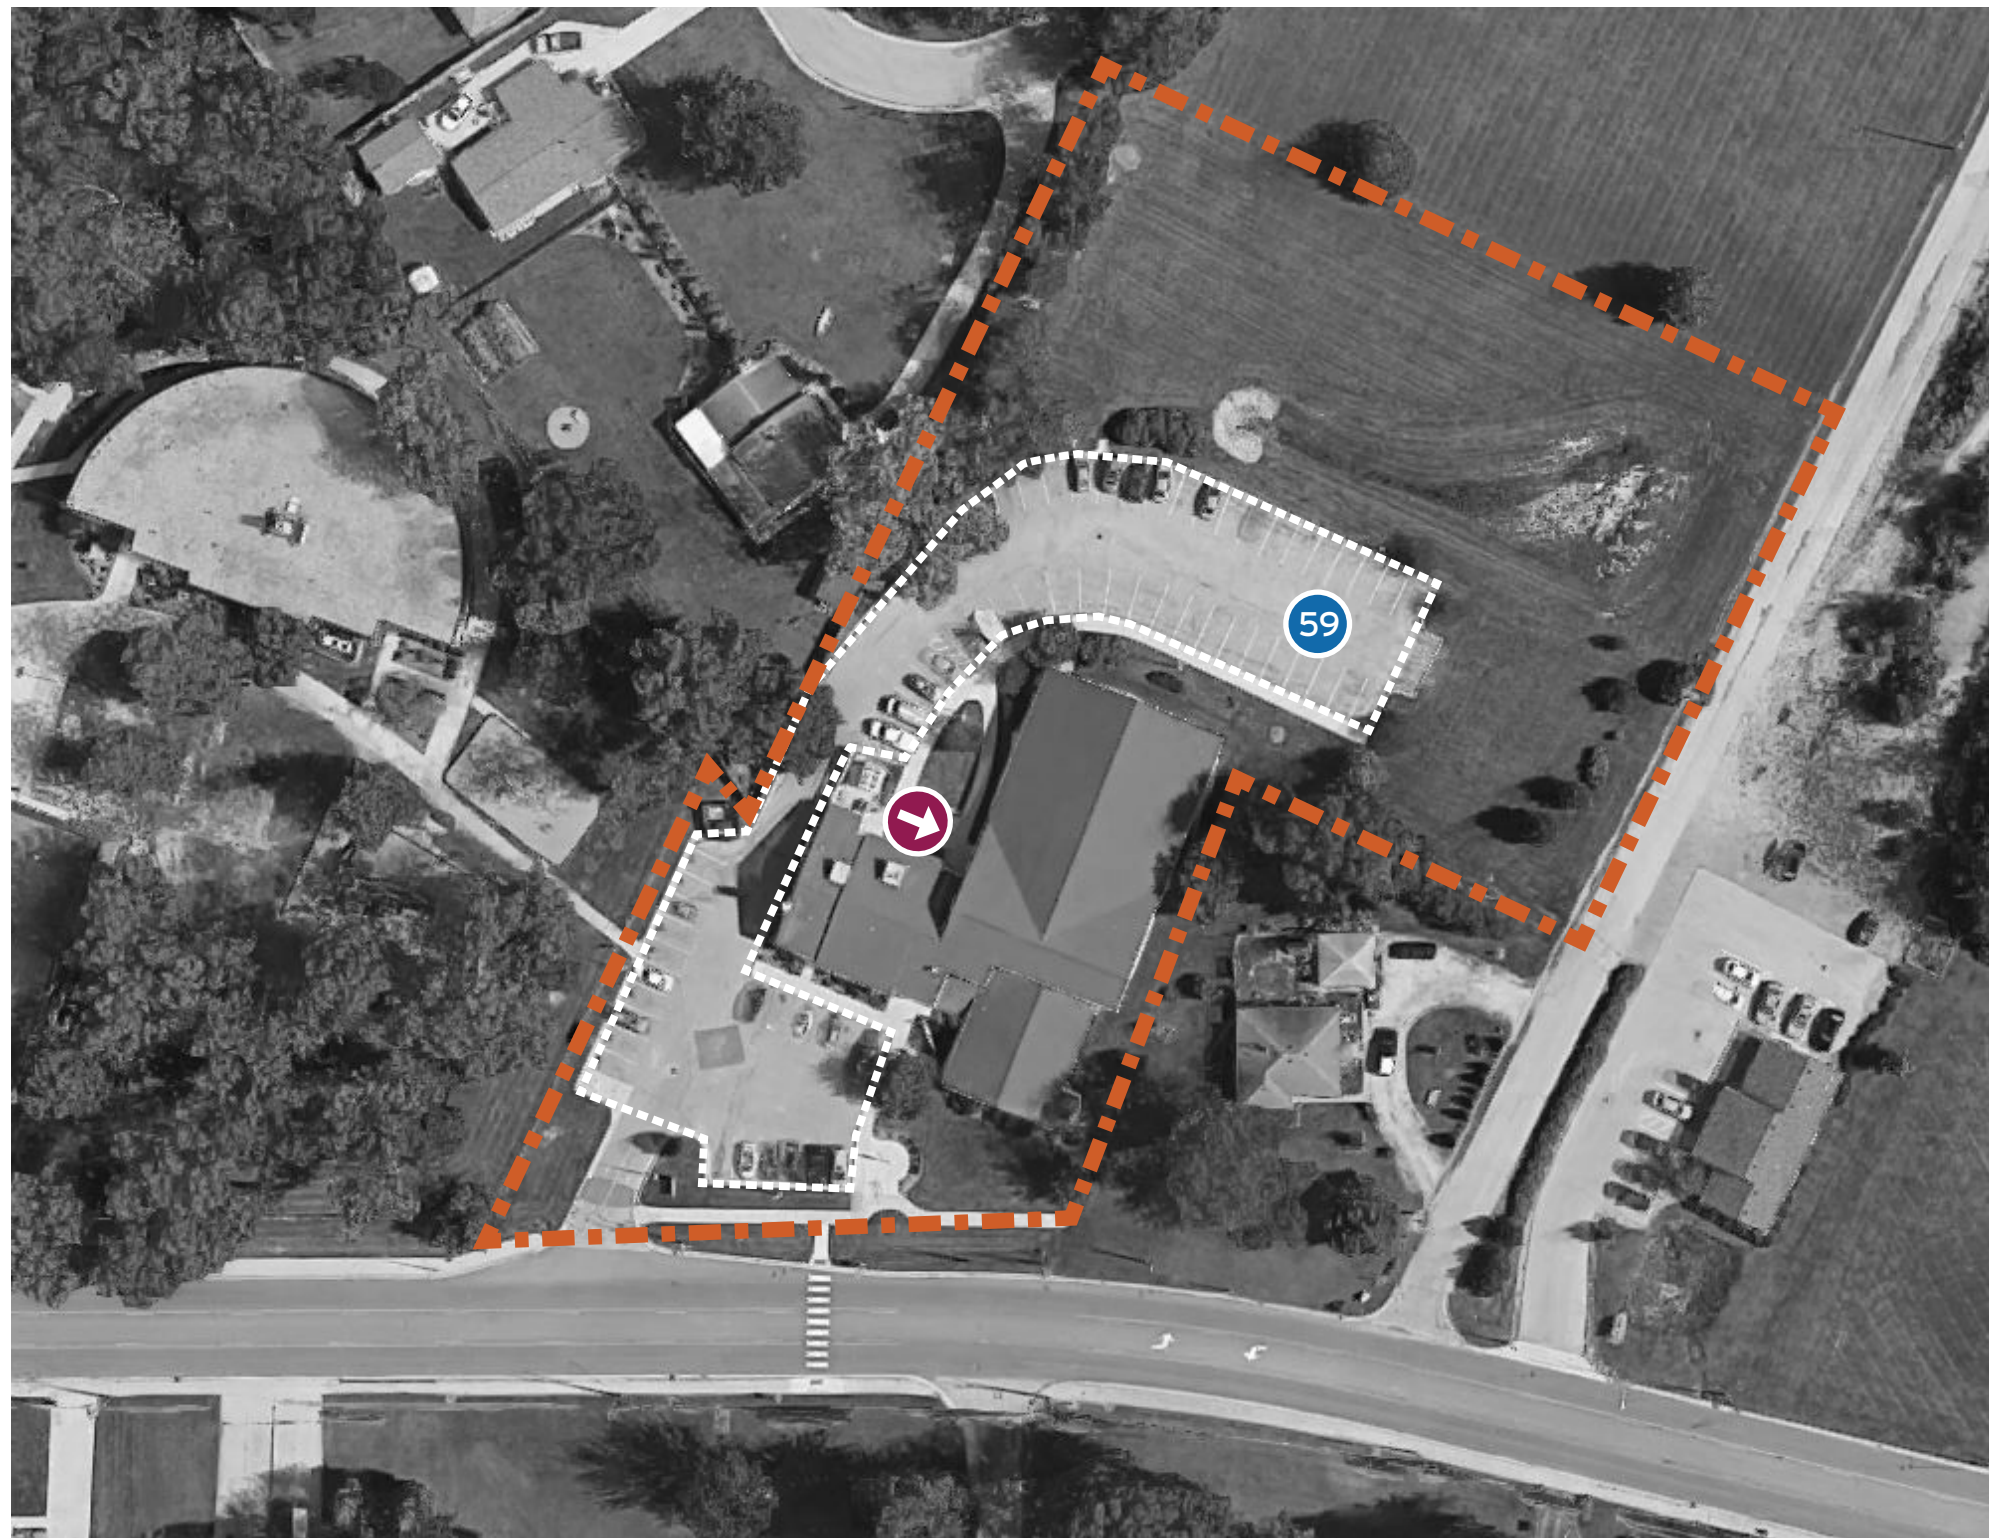
Site Plan

The front lot is easily accessed and obvious from the street, although the entrance drive is narrow and seen as a collision hazard. The front lot includes four accessible parking spaces, however the ramp to access the building is inappropriately placed to the south of and well behind all the ADA spaces. It is not obvious that the back parking lot can also be used by library patrons.

A wood fence along the neighboring yard to the west needs repair.

The site is generous and has ample green space to the north. Exterior spaces have not been developed for library programming.

The property could support expansion, although the architectural design and layout does not lend itself to easy expansion.

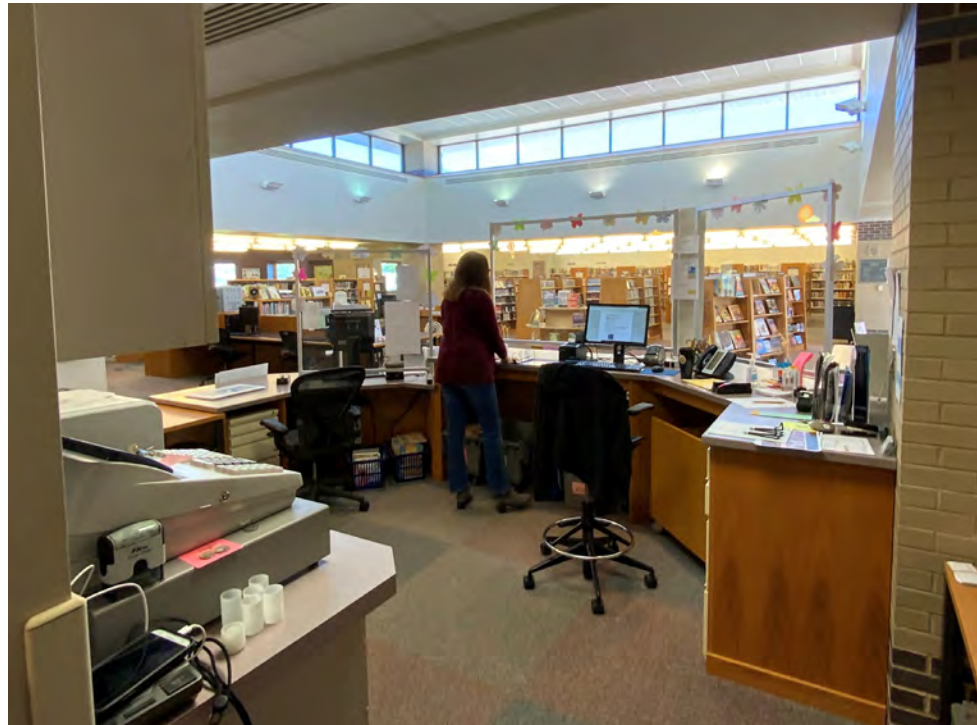
Woodburn is small, but adequately sized for the community served and volume of use.

- The branch layout is a simple and straightforward, and generally flexible except for the size limitations.
- The meeting room is approximately 550 SF and is undersized for larger groups. It includes an adequate presentation wall but storage is shared with custodial staff and inadequate for the building.

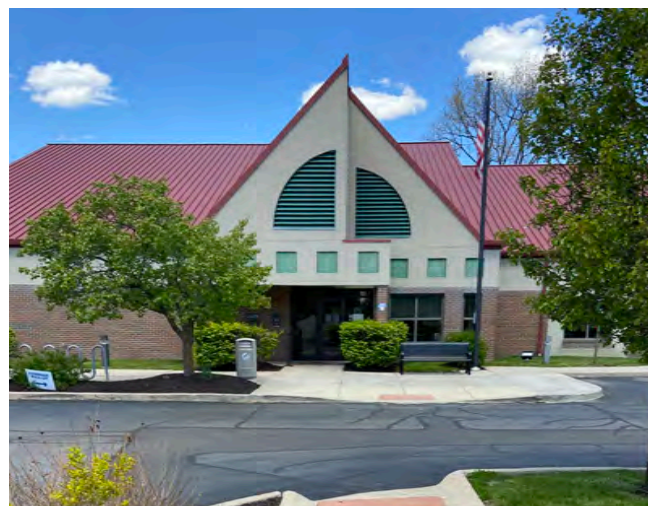
Aboite is undersized to accommodate current demands in rapidly growing southwest Allen County area it serves. The building is in poor condition relative to other branches, including structural concerns and settling along a ravine to the north. The current site cannot accommodate expansion to meet the projected 10-year service demand.

A new 25,000 SF Aboite Branch is recommended on a new site to be determined in this service area. The existing branch property could be vacated and sold, but would remain open until the new branch is occupied.

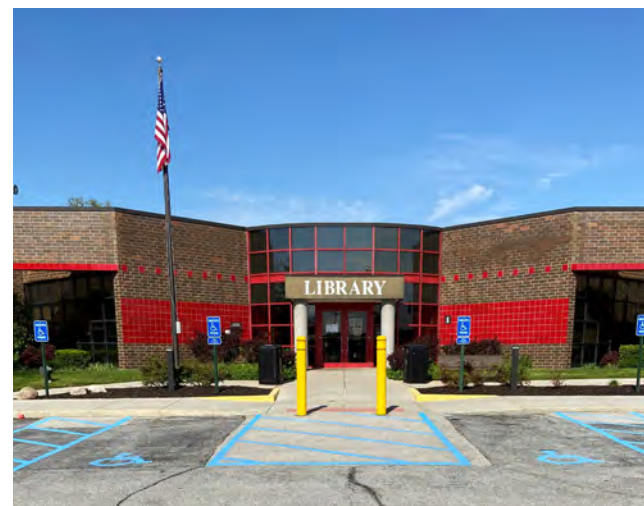
Dupont is undersized to accommodate current demands in the rapidly growing north central and northwest Allen County area it serves. The building is in poor condition relative to other branches, with no major improvements since 1996. The current site cannot accommodate expansion to meet the projected 10-year service demand.

A new 25,000 SF Dupont Branch is recommended on a new site to be determined, in this service area and a little south of the current location to assist with appropriate branch distribution in northwest Allen County. The existing branch property could be vacated and sold, but would remain open until the new branch is occupied.

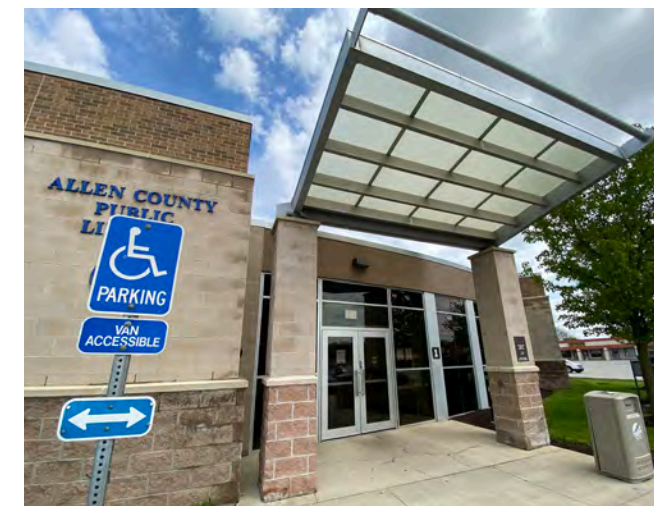
Georgetown is undersized to accommodate current demands in the northeast quadrant of Fort Wayne. The building is in good condition relative to other branches, but experiences a volume of children and teens from nearby schools that exceed the building's capacity to satisfy. The current site cannot accommodate expansion to meet the projected 10-year service demand.

A 25,000 SF Georgetown Branch is recommended. The preferred way to achieve this would be to expand the current branch in place, requiring the acquisition of adjacent property not yet owned by ACPL. If this preferred method proves unachievable, the alternative would be to build a new 25,000 SF branch at a new site to be determined as near the current location as possible, possibly in nearby retail space of the appropriate size. In this option the existing branch property could be vacated and sold, but would remain open until the new branch is occupied.

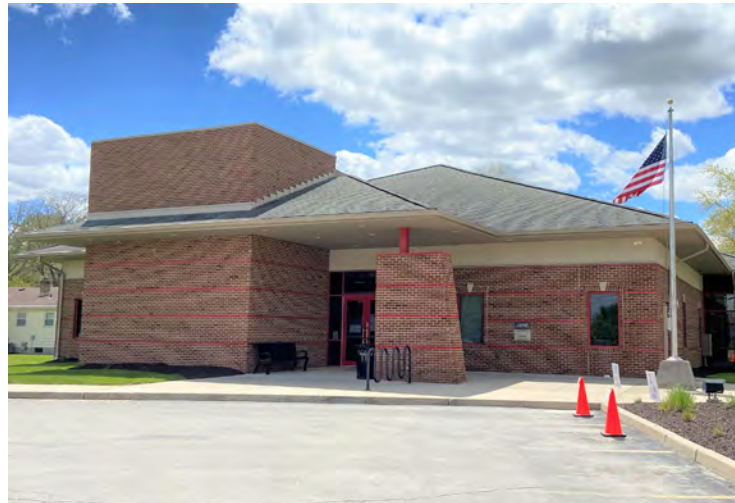
Grabill is undersized to accommodate current demands in the growing northwest Allen County area it serves. The building is in decent condition relative to other branches, but the usage has outgrown the current branch size. The current site can accommodate expansion to meet the current projected 10-year service demand.

A 12,000 SF Grabill Branch is recommended, achieved by renovating the existing branch and expanding by approximately 4,000 SF on the current site.

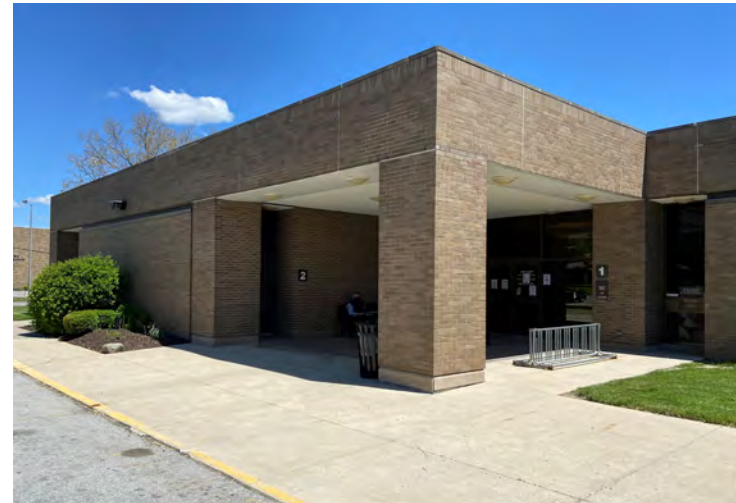
Hessen Cassel is appropriately sized to accommodate current and anticipated 10-year demands in the southeast quadrant of Fort Wayne, although the configuration is poor, particularly in access to public meeting spaces. The building is in poor condition relative to other branches, including older infrastructure and a need for significant masonry repairs. The current site is capable of expansion should the service demand over time exceed the ability for the current branch to satisfy it.

A comprehensive renovation of the existing Hessen Cassel Branch is recommended, including targeted reconfiguration and system upgrades or replacements as appropriate to improve conditions and enhance service delivery to patrons in this community. Special consideration to improve the meeting room is required.

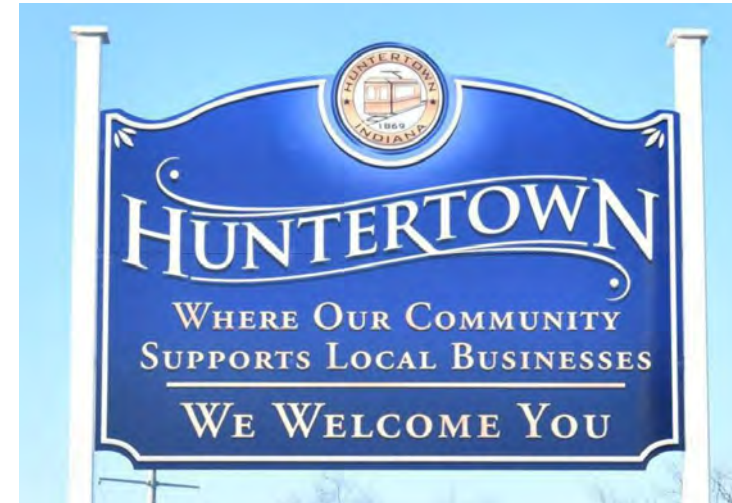
New Branch in Huntertown area

The population growth in northern and northwestern Allen County has created a current and projected service demand that cannot be adequately served by the existing Dupont and Grabill branches. To accommodate this need, a new 10,000 SF minimum branch is recommended on a new site to be determined in this service area. The site should be large enough and the building should be designed to anticipate a branch expansion up to a total future branch size of 25,000-30,000 Sf over time.

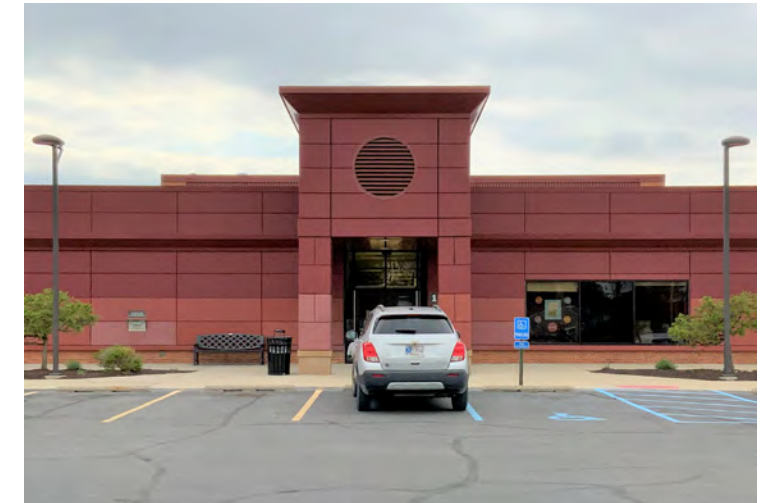
Little Turtle is appropriately sized to accommodate current and anticipated 10-year demands northwest of downtown Fort Wayne. The building is in adequate condition relative to other branches, retrofitted from a former grocery store with the last renovation in 2006. The current site is capable of modest expansion, at the expense of parking, should the service demand over time exceed the ability for the current branch to satisfy it.

A renovation of the existing Little Turtle Branch is recommended, including targeted reconfiguration and system upgrades or replacements as appropriate to improve conditions and enhance service delivery to patrons in this community.

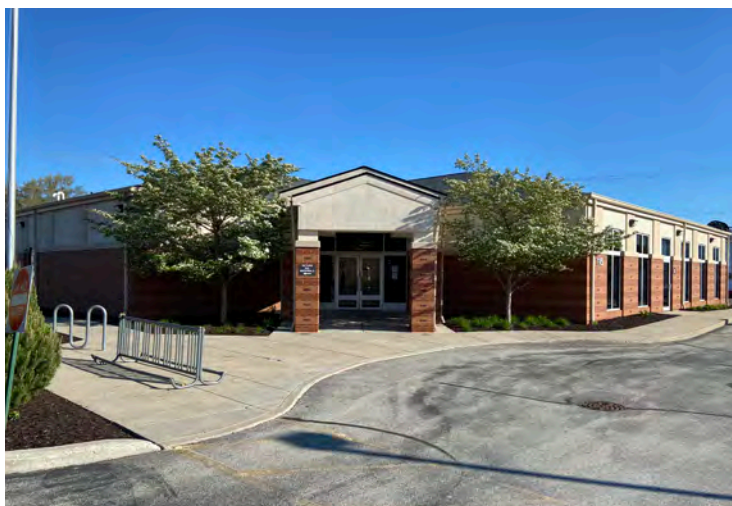
Monroeville is small relative to other branches but appropriately sized to accommodate current and anticipated 10-year demands in southeast Allen County. The building is in good condition relative to other branches, a well-maintained facility built in 2003. The current site cannot accommodate expansion, should the service demand over time exceed the ability for the current branch to satisfy it.

A renovation of the existing Monroeville Branch is recommended, including targeted reconfiguration and system upgrades or replacements as appropriate to improve conditions and enhance service delivery to patrons in this community.

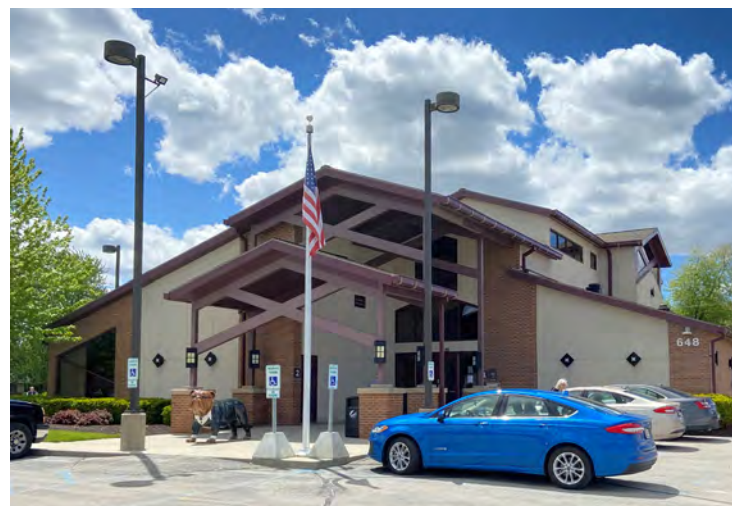
New Haven is appropriately sized to accommodate current and anticipated 10-year demands of this city and surrounding community in east central Allen County. The building is in adequate condition relative to other branches, although the site configuration has been noted as a challenge. The building is geometrically complex, but it and the current site could accommodate a modest expansion into some surrounding green space, should the service demand over time exceed the ability for the current branch to satisfy it.

A renovation of the existing New Haven Branch is recommended, including targeted reconfiguration and system upgrades or replacements as appropriate to improve conditions and enhance service delivery to patrons in this community.

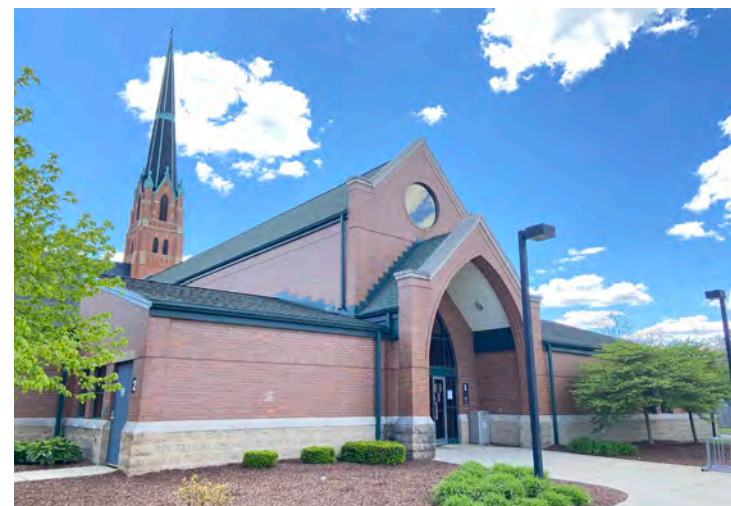
Pontiac is appropriately sized to accommodate current and anticipated 10-year demands southeast of downtown Fort Wayne. The building is in good condition relative to other branches, a well-maintained facility built in 2004. The current site is capable of some expansion, at the expense of parking, should the service demand over time exceed the ability for the current branch to satisfy it.

A renovation of the existing Pontiac Branch is recommended, including targeted reconfigurations, possible site improvements to minimize distance from parking, and system upgrades or replacements as appropriate to improve conditions and enhance service delivery to patrons in this community.

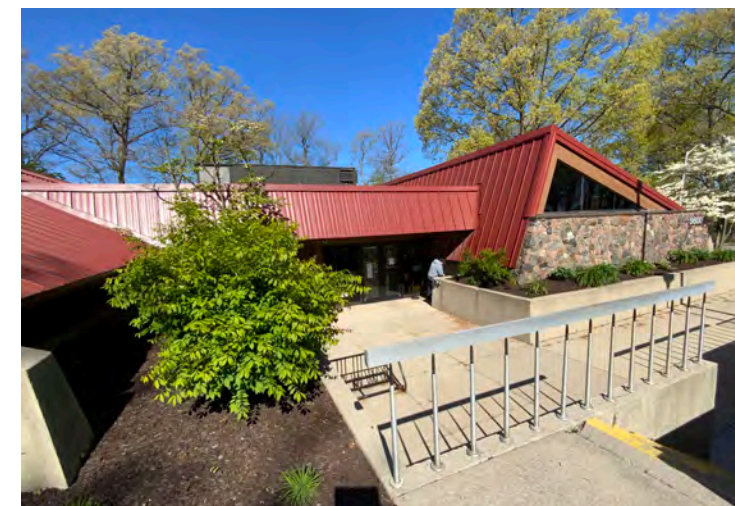
Shawnee is appropriately sized to accommodate current and anticipated 10-year demands in the southeast quadrant of Fort Wayne, although the configuration and condition concerns outweigh space adequacy. The building is in poor condition relative to other branches, and being half-buried into the site creates unique access and egress challenges, as well as temperature control issues, leaks, and pest intrusion concerns. The current building configuration could not accommodate expansion should the service demand over time exceed the ability for the current branch to satisfy it.

A new 20,000 SF Shawnee Branch is recommended on a new site to be determined, as close as possible to the existing Shawnee Branch, possibly in nearby retail space of the appropriate size. The existing branch property could be vacated and sold, but would remain open until the new branch is occupied.

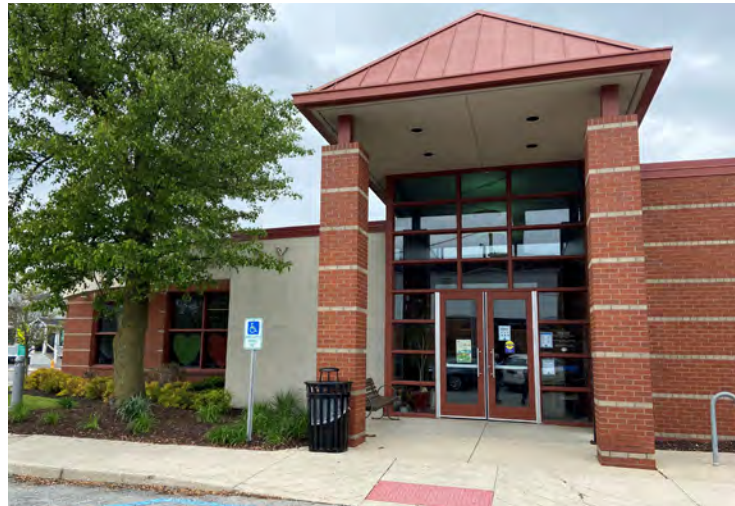
Tecumseh is appropriately sized to accommodate current and anticipated 10-year demands northeast of downtown Fort Wayne. The building is in adequate condition relative to other branches, with the last renovation in 2005. The current site is capable of modest expansion, at the expense of a new garden and/or some parking, should the service demand over time exceed the ability for the current branch to satisfy it.

A renovation of the existing Tecumseh Branch is recommended, including targeted reconfiguration and system upgrades or replacements as appropriate to improve conditions and enhance service delivery to patrons in this community.

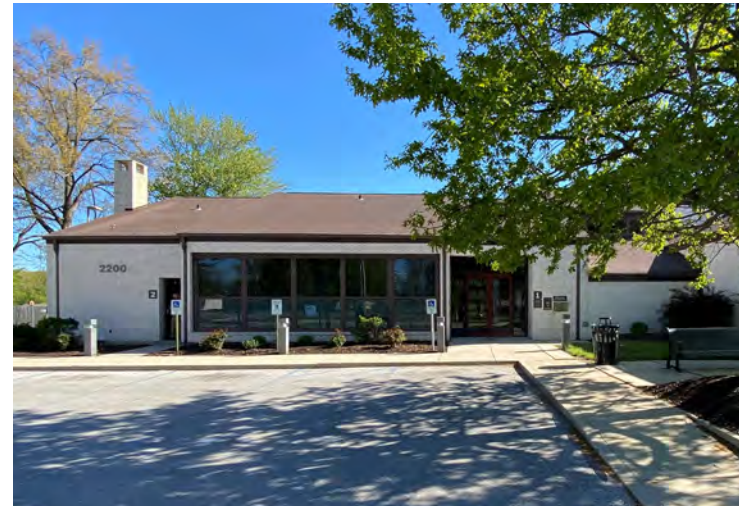
Waynedale is appropriately sized to accommodate current and anticipated 10-year demands in this area, however the meeting room and staff workspaces are configured in a way that may necessitate a targeted expansion as outlined below. The building is in adequate condition relative to other branches, with the last renovation in 2005. The current site is capable of expansion, should the service demand over time exceed the ability for the current branch to satisfy it or should an expansion be determined a beneficial priority among the options below.

A renovation of the existing Waynedale Branch is recommended, including targeted reconfiguration and system upgrades or replacements as appropriate to improve conditions and enhance service delivery to patrons in this community. An expansion of the branch by approximately 2,500 SF is also recommended, to add a larger meeting space and correct accessibility and functional concerns in the staff area.

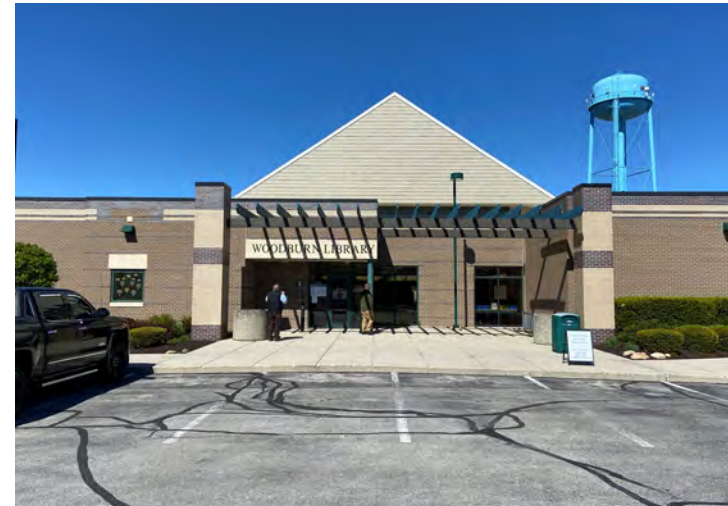
Woodburn is small relative to other branches but appropriately sized to accommodate current and anticipated 10-year demands in east Allen County. The building is in good condition relative to other branches, a well-maintained facility built in 2003. The current site can be developed for programming and is able to accommodate expansion, should the service demand over time exceed the ability for the current branch to satisfy it.

A renovation of the existing Woodburn Branch is recommended, including targeted reconfiguration and system upgrades or replacements as appropriate to improve conditions and enhance service delivery to patrons in this community.

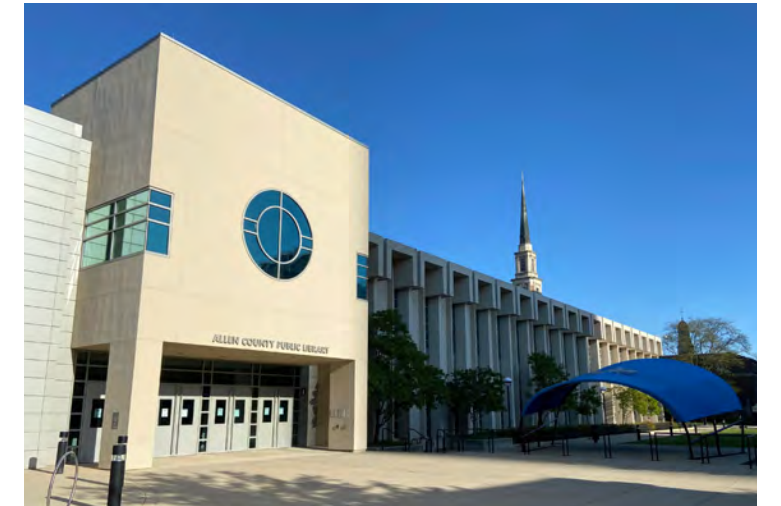
Main Library

As the flagship branch of ACPL, Main is appropriately sized to accommodate the combination of collections and services it offers patrons in Allen County and beyond. The building is in good condition, having benefitted from a comprehensive expansion and renovation completed in 2007. The site is capable of modest expansion at the expense of adjacent drives and/or landscaping, should the demands over time change in a way that necessitates growth.

Recommendations for Main are more qualitative than quantitative, and include targeted improvements such as: improve collection navigability to enhance patron experience; add medium and small meeting room spaces; design to improve function and acoustics in the great hall; address noise transfer between Genealogy and Readers Services; renovate the vacated café space to an appropriate public service area; and redesign the east entrance to be brighter and more welcoming.
