# Tecumseh

### GENERAL INFORMATION

## BRANCH CONDITION

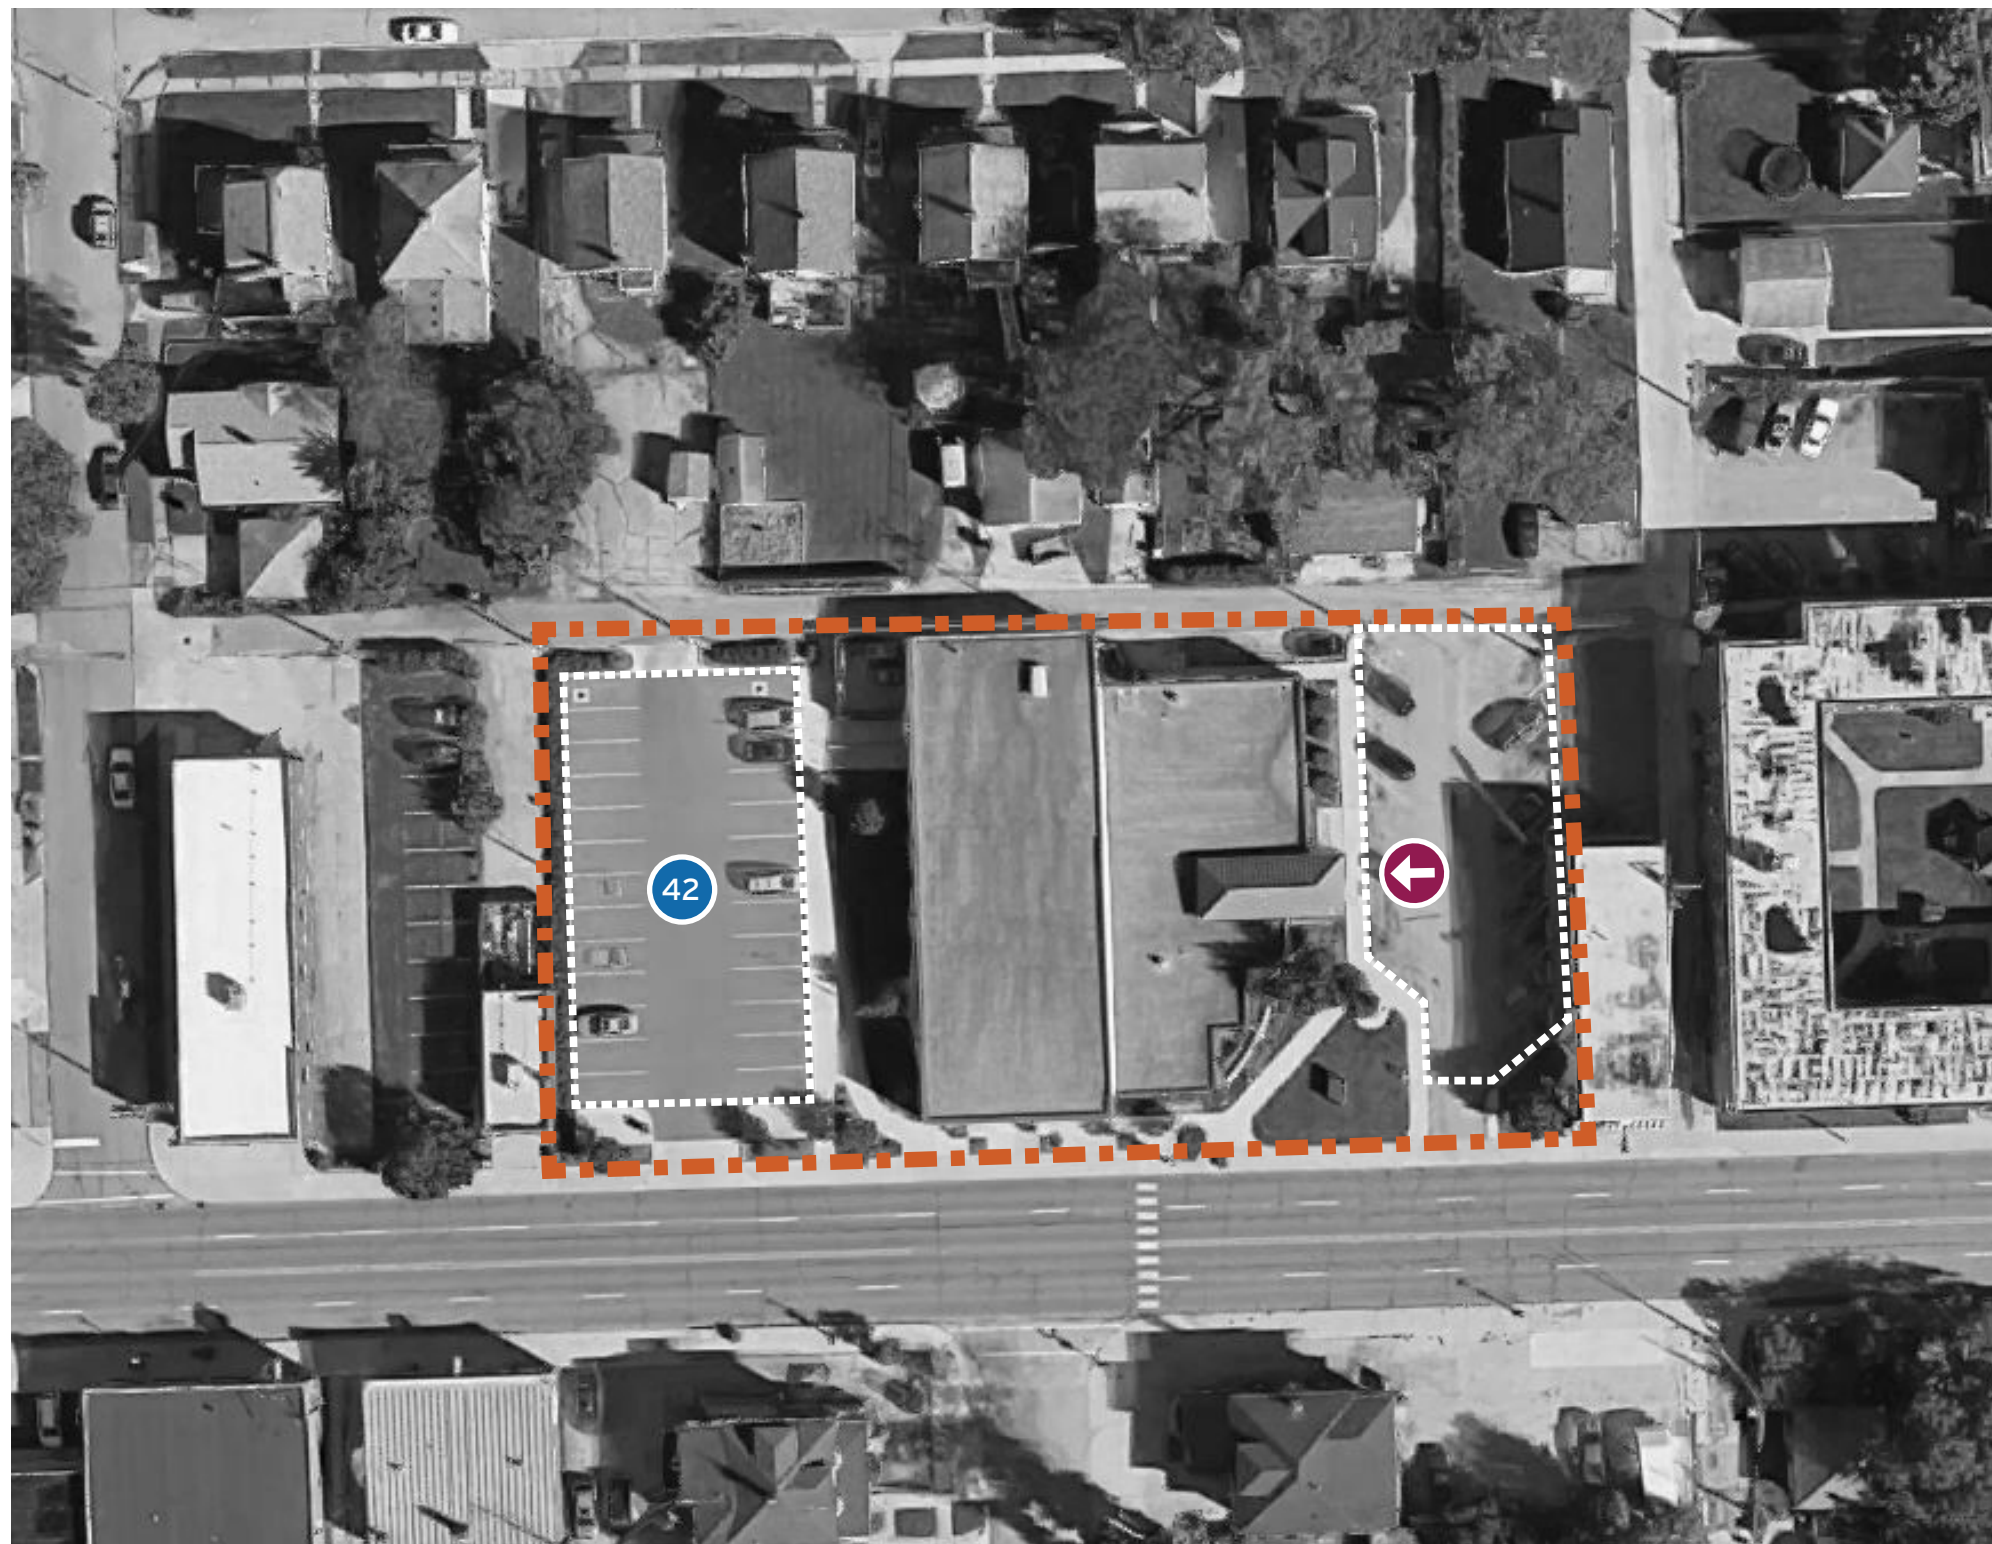
Site Plan

The branch and library sign are easily visible from East State Boulevard. The building entrance is visible coming from the east, but the south (street-facing) façade has no windows and does not project a significant presence as a library.

The parking lot includes 42 spaces, easily accessed and obvious from the street, but problematic in that the entrance is adjacent to a smaller one-way parking lot with 14 spaces, and the large lot with 28 spaces requires pedestrians to walk around the building to enter.

The site has some green space to the west and at the southeast corner near the entrance, some of which has been used for programming and is planned to be developed into a Pollinator Prairie Garden. The parking lot west of the building was designed specifically to support events.

The property is not large enough to support any significant expansion. Some modest renovation could occur near the entrance or along the west wall.
