Shawnee

GENERAL INFORMATION

Address	5600 Noll Ave Fort Wayne, IN 46806
Building Size	11,200 SF
Site Area	1.43 Acres
On Site Parking	22
Year Built	1973, Renovation 2003
Original Architect	Jankowski Schultz

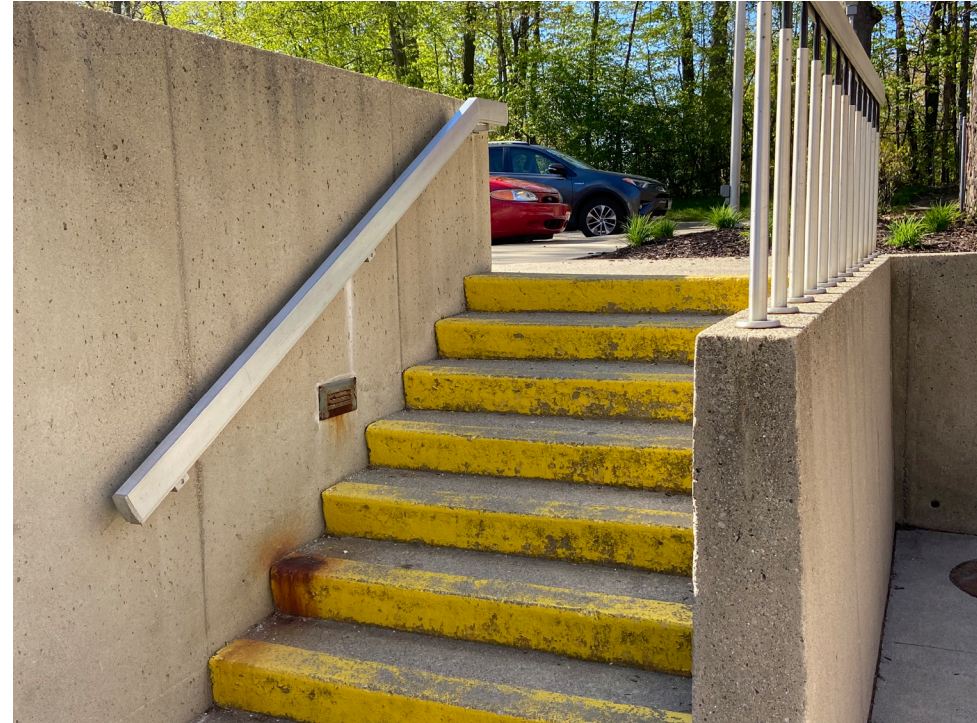
"Not accessible. Seems kind of dark. I can see why the building and location isn't ideal for expansion or remodel. It would be nice to still have a neighborhood library in that area though that may be difficult."

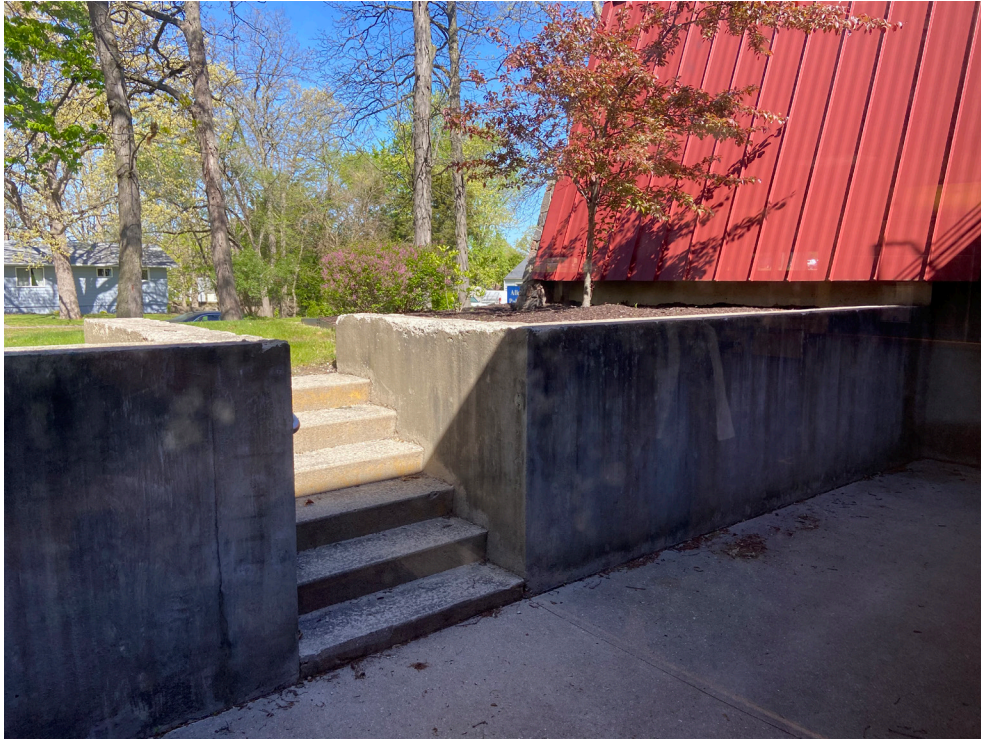
"The stairs down to the entrance are scary in the winter, and not a great option for folks that don't move so well. There may be an additional entrance, but I am unaware of it personally."

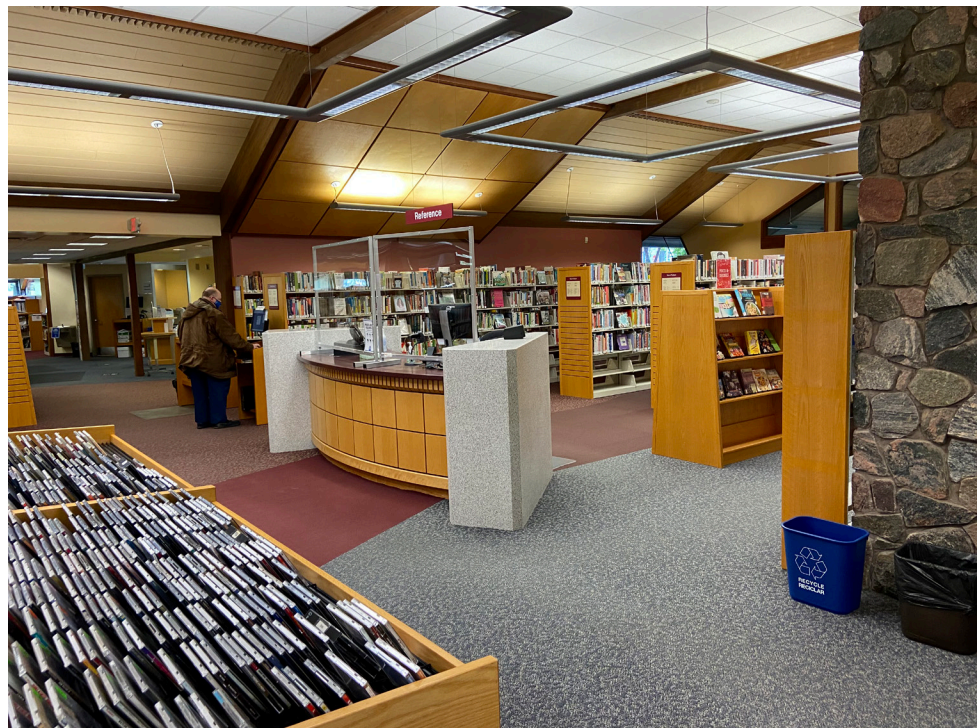
"Flooring is outdated and worn; also, the big service desk right in front when you enter makes it hard to see the rest of the space and makes it feel smaller than it is."
